TO THE MAYOR AND COUNCILLORS OF THE MACKENZIE DISTRICT COUNCIL

PROJECTS AND STRATEGIES COMMITTEE

Agenda for Tuesday 11 June 2013

SUBJECT: PIONEER PARK/OLDFIELDS ROAD BRIDGE REPLACEMENT

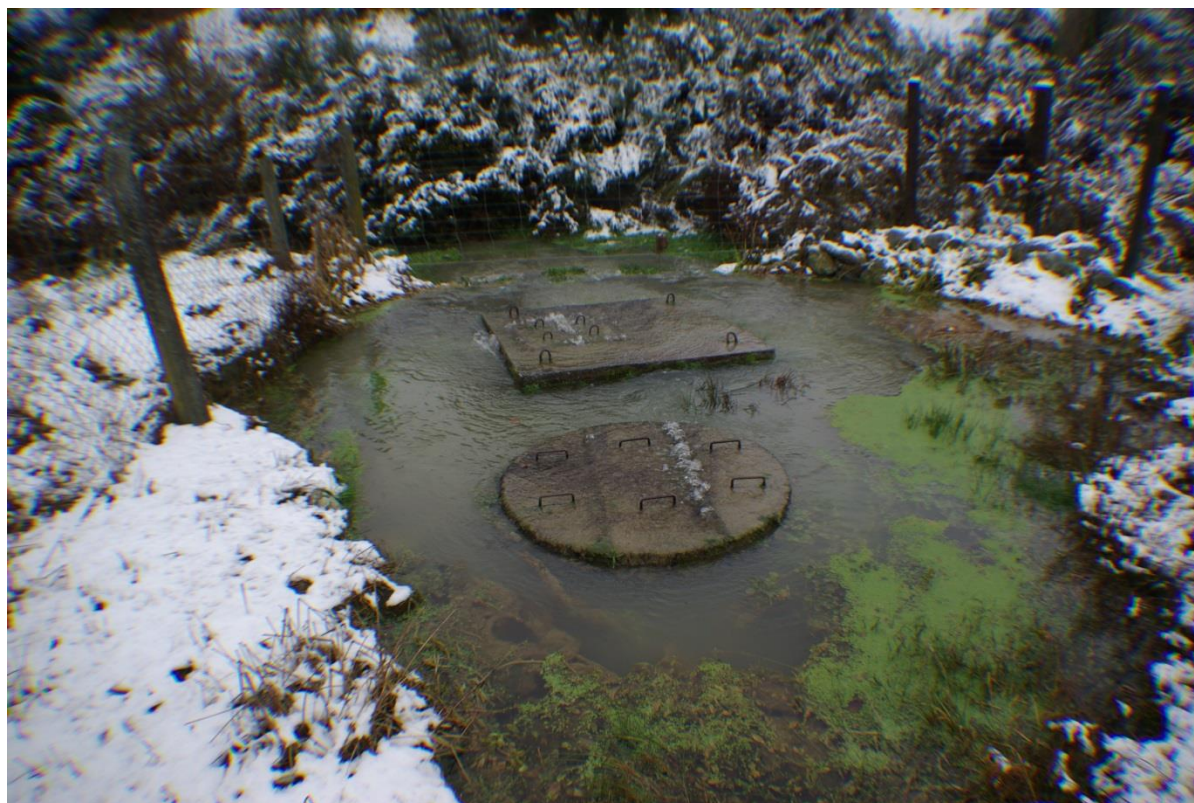
Fairlie - Current well source Queens Birthday weekend

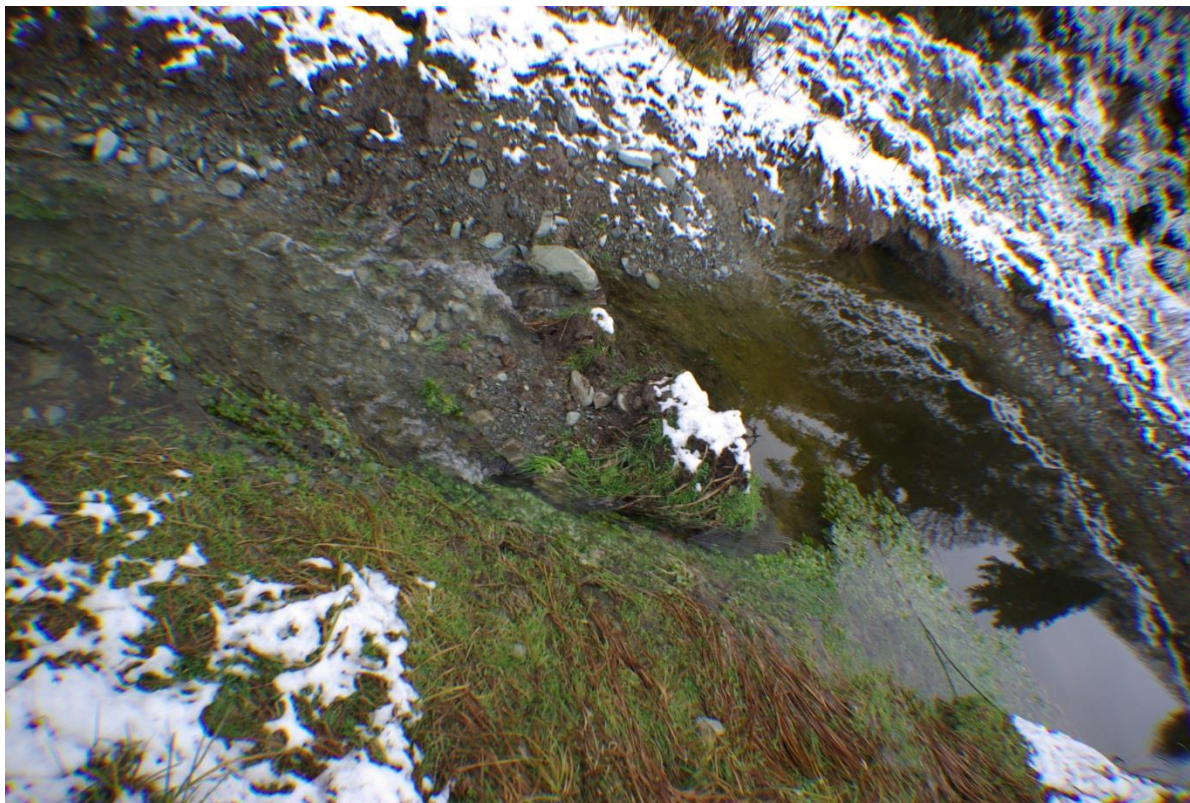
Fairlie - Proposed well source Queens Birthday weekend

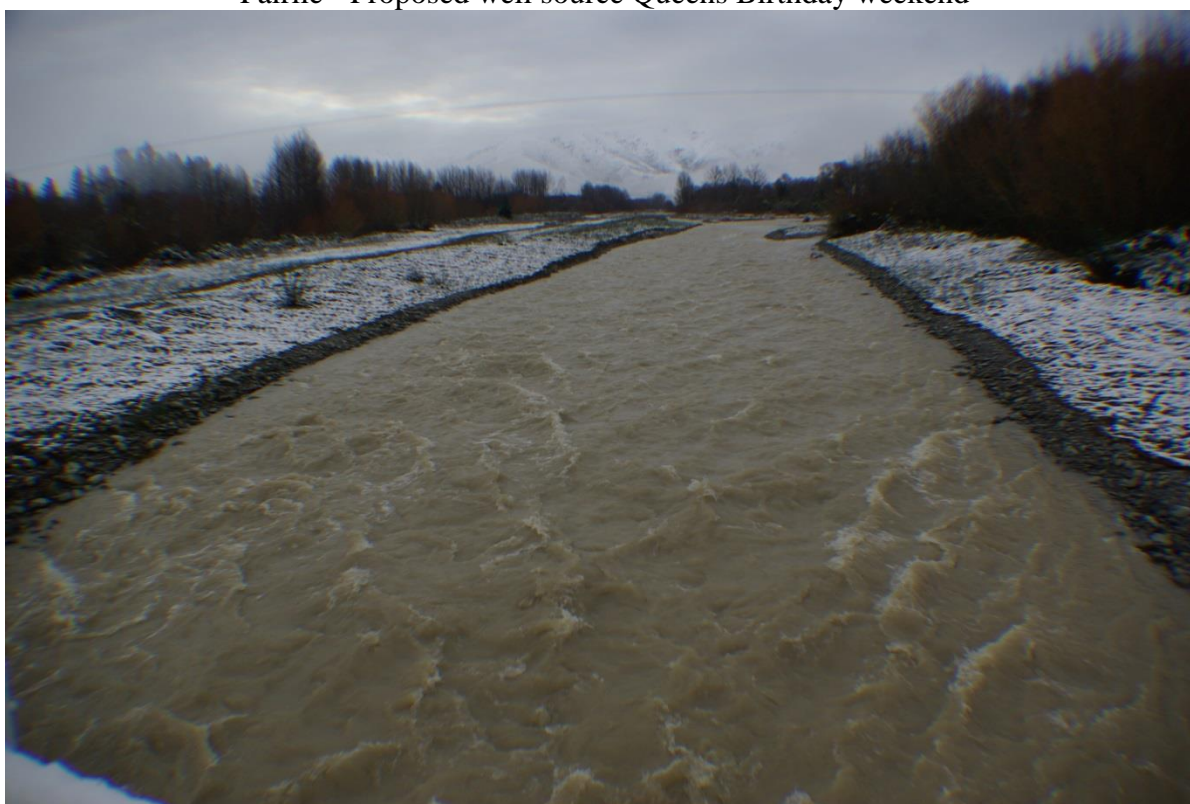
Fairlie – Opihi River at Stoneliegh on Queens Birthday weekend

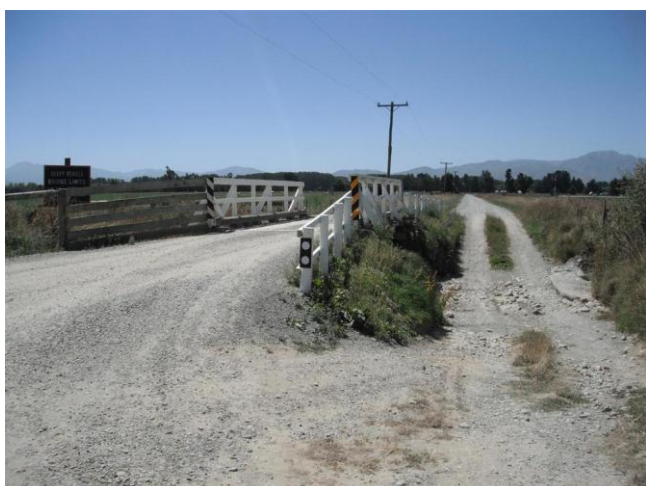
Photo 1: General view of bridge and ford, looking north towards SH8

The road, bridge and ford appear to be well used although inventory data records traffic demand as less than 50 vehicles per day. The ford is roughly formed with a concrete bund acting as a weir at the downstream edge to retain the bed, but is in good serviceable condition. At the south end, the approach to the ford is relatively steep and a sharp turn is required to access properties to the west; this combination may be problematic for overweight and oversize vehicles to negotiate.

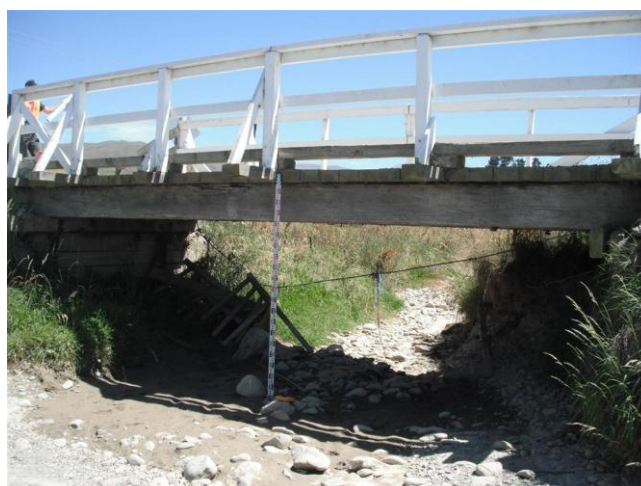
Photo 2: Elevation looking upstream

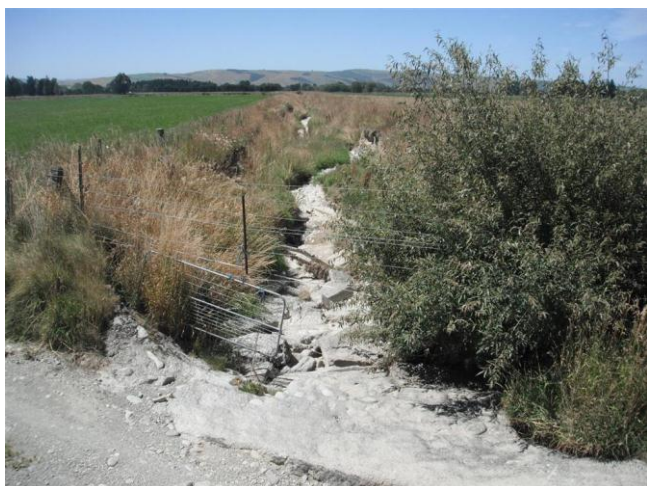
The bridge crosses the north branch of Wellshot Stream which at the bridge site is well confined between stable and well-vegetated banks with rank grass lining the channel margins. The catchment is 100% vegetated, mostly by pasture on the river flats and unimproved grassland in the hills. In contrast to upstream, the bed downstream of the bridge site is devoid of fine gravels (refer photos 3 and 4), indicative of moderately active degradation.

Photo 3: Waterway downstream of bridge (concrete weir in foreground)

There is a modest drop in the streambed beyond the ford and a lack of fines in the downstream bed, indicating that degradation is active at this site. Bed levels measured 25 m upstream and downstream indicate that the ford is perched up to a metre above the natural channel gradient. At present, the ford/weir is retaining gravels under the bridge and protecting the piles from degradation, however unless it is maintained the downstream edge of the ford is likely to become undermined over time, compromising the performance of the ford and exposing the bridge abutments to scour. The foundations for a replacement bridge should be designed to accommodate this potential for scour/degradation.

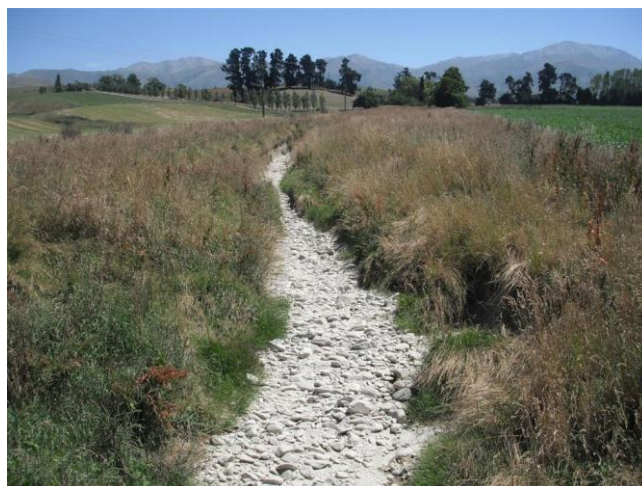
Photo 4: Waterway upstream of bridge

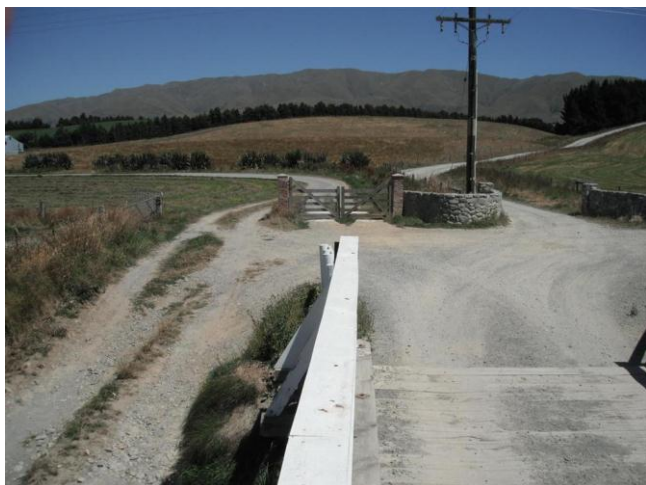
The southern abutment of the existing bridge is approximately 15 m from the end of the road reserve, where a stacked stone wall marks the boundary. The main traffic flows turn to the right immediately after the bridge (refer photo 5). The utility of the ford appears to be limited with the current layout as an overweight or oversize vehicle must turn hard right as it is climbing out of the ford in order to make the turn, effectively sidling up the side of the bridge approach while turning. The replacement bridge will likely require walls to more positively retain the bridge approaches (currently un-retained over-steep batters), which may further restrict the right turning movement of vehicles using the ford. It is recommended that the space occupied by the downstream ford is utilised to widen the bridge, thus catering for all vehicles on the bridge and improving the geometrics of the site. If the replacement is located downstream, the northern approach will also line up with the bridge rather than offset as exists currently (refer photo 1).

Photo 5: Southern approach to bridge
(main traffic flow continues to the right)

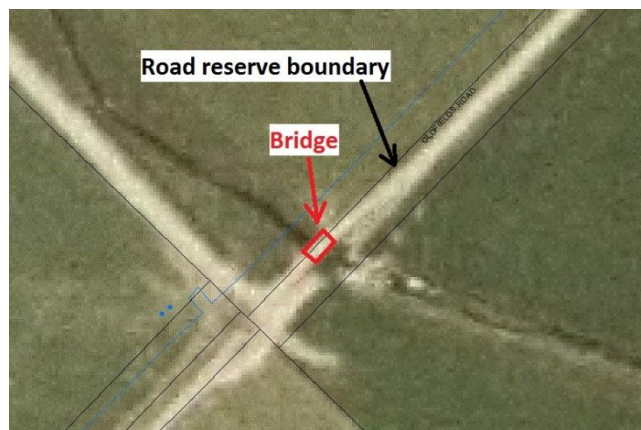
In addition, aerial photographs of the bridge site from the MDC online mapping service (refer photo 6) indicate that the existing bridge may be constructed on or very near to the road reserve boundary. Ideally a replacement structure should be built entirely on road reserve, i.e. slightly downstream of the existing.

Photo 6: Aerial view of bridge

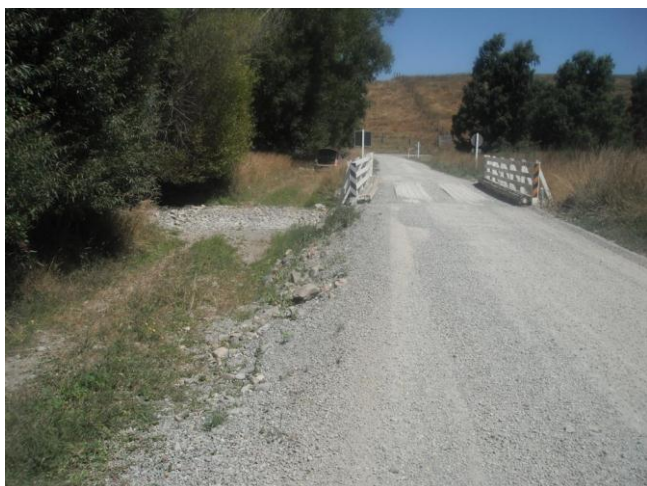
Photo 7: General view of site looking south (downstream ford to left, secondary flow path and Homebush Road in background).

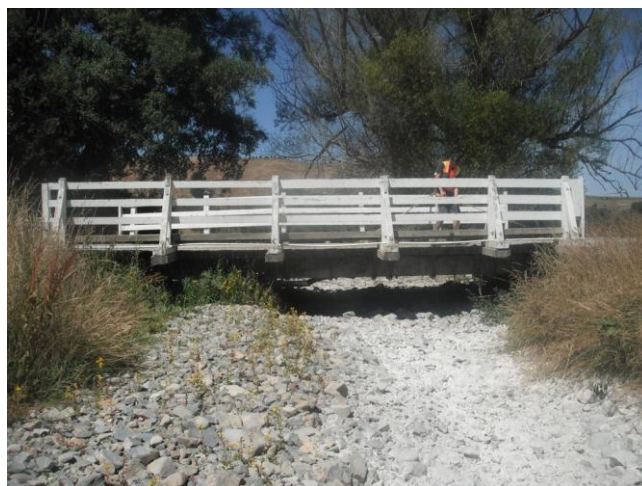
Photo 8: Bridge elevation (looking downstream)

The bridge is currently posted with a 70% Class 1 maximum gross vehicle weight restriction and a speed restriction of 10 km/h. The road appears well used although the bridge inventory records traffic demand as less than 50 vehicles per day. A gravel ford downstream provides an offline bypass for overweight vehicles and although it is serviceable it appears to be rarely used.

A reinforced concrete bridge is the preferred option for the replacement of Pioneer Park Bridge, as it will provide a relatively low cost, robust, environmentally appropriate crossing for this site. Resource consent requirements are minimised, and the reduced extent of site works for bridge construction compared to a box culvert minimises construction cost.

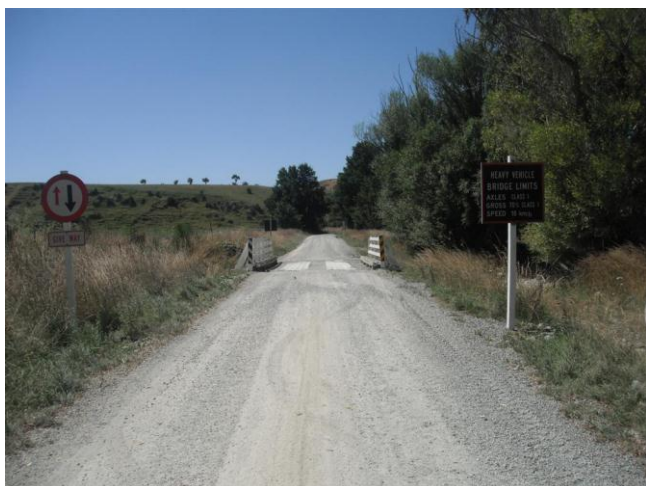
Photo 9: View over bridge looking north

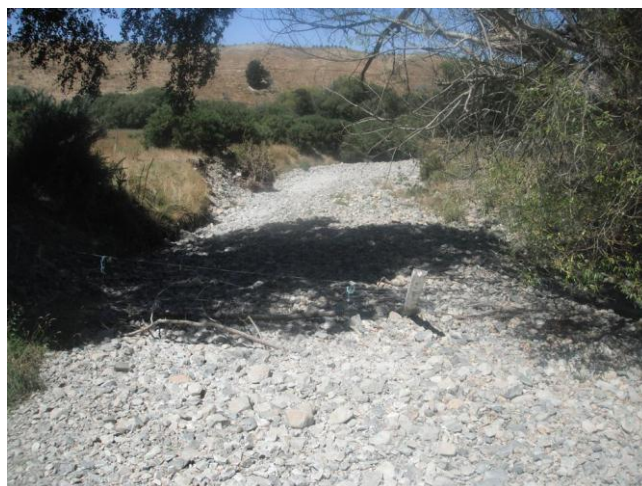
Photo 10: Waterway downstream of ford

No scour around the bridge is evident at present, however the stream bed material appears to be highly mobile and likely to experience aggradation/degradation cycles over time.
