Proposed Plan Change 19

ACTIVITIES ON OR WITHIN WATERBODIES

(LAKE PUKAKI)

ASSESSMENT OF VISUAL EFFECTS

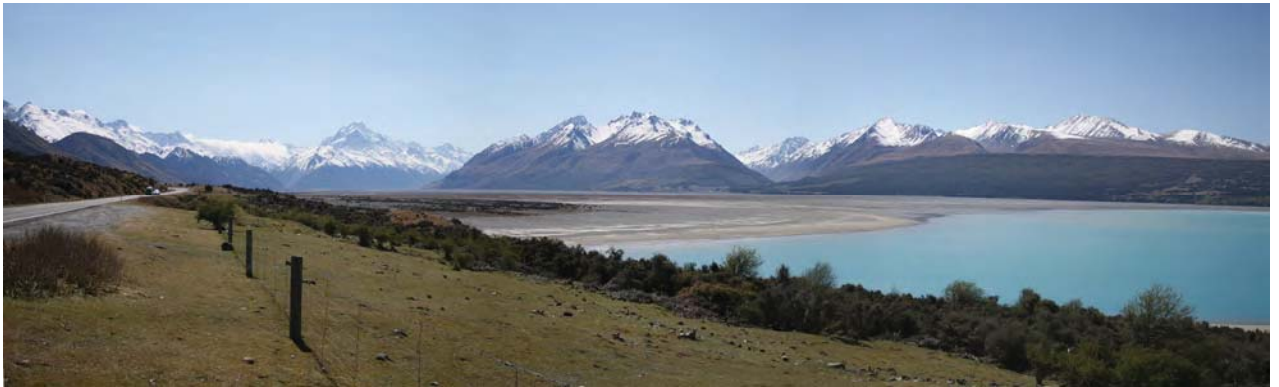
Viewpoint 1 Looking northwards to Aoraki Mount Cook near head of Lake Pukaki. Note elevation (and elevated viewpoint) above lake here. Photograph by J Head, October 3, 2018 f=50.

12. Most of the viewpoints along SH80 are elevated well above the lake surface (Viewpoint 1). The terrain drops down from the road to the lakeshore quite sharply in places where bluffs occur. Taller vegetation cover is limited on the lakeside of SH80 which allows for almost unfettered views down and across the lake. In terms of potential lake access points this is limited to:

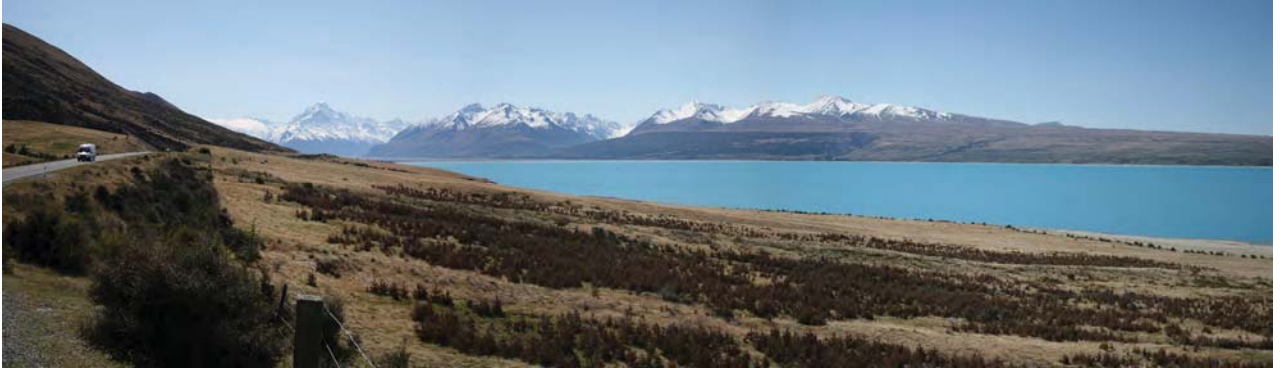
Viewpoint 2 Looking northwards to Aoraki Mount Cook from Jacks Stream fan. Note general absence of tall roadside vegetation which would screen views to the lake and mountain view to the east side of SH80. Aoraki Mount Cook visible at left. Photograph by J Head, October 3, 2018 f=50.

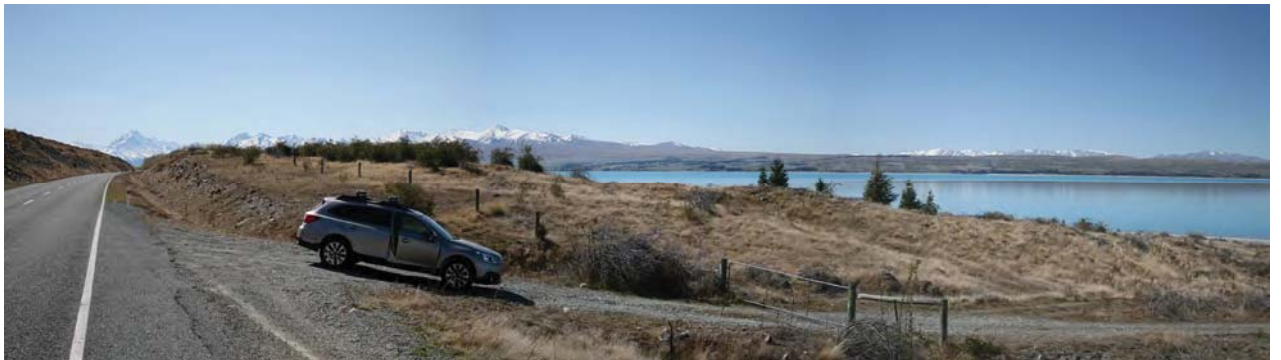
Viewpoint 3 Farm access to lake from Boundary Stream. Note difficulty in accessing/leaving SH80 (at left) from these access points. Aoraki Mount Cook visible above highway. Photograph by J Head, October 3, 2018 f=50.

13. Any potential access points along the western side of the lake have not been mapped on Appendix 1 for the following reasons:
- Privately owned land was not visually assessed in detail.
 - Most areas included traversing significant areas of farmland (broad alluvial fans) where public access may not be feasible or desired by the landowner (Viewpoint 2).
 - Access to SH80 appeared potentially dangerous – particularly with regards to slow moving vehicles with trailers leaving and accessing the highway with 100kph speed limits¹⁰ (Viewpoint 3).

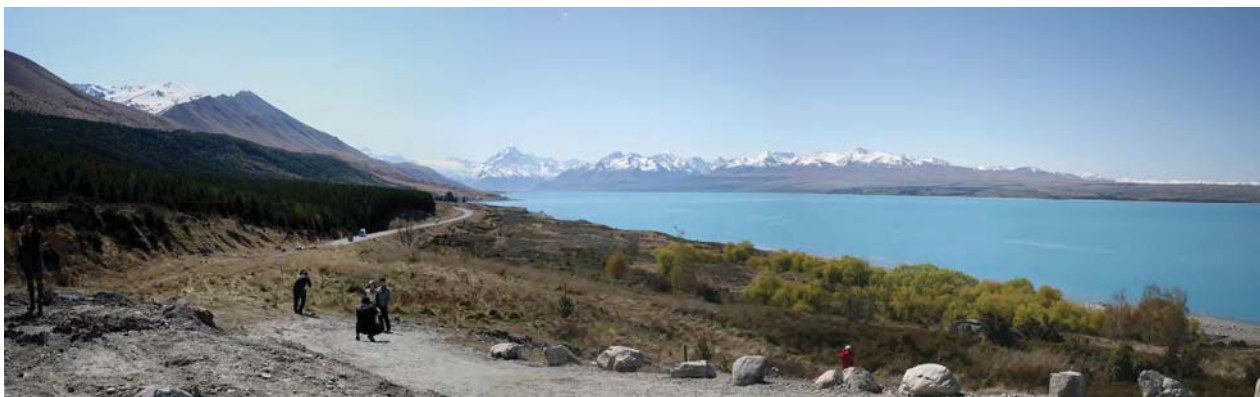
Viewpoint 4 From 'Peters Lookout' looking northwards to Aoraki Mount Cook. Aoraki Mount Cook visible at centre. Much of the taller vegetation along this side of the lake has been removed or is limited to the west side of SH80 (visible at centre-left) Photograph by J Head, October 3, 2018 f=50.

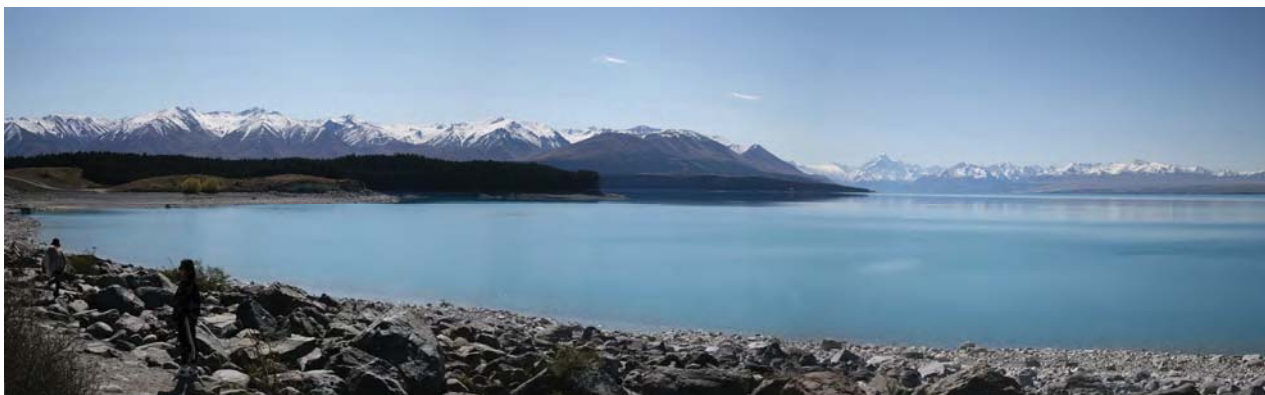
Viewpoint 5 View northwards up the lake from near the Pukaki Information Centre. At this time the lake was very flat providing a sharp contrast to the mountains to the north – including Aoraki Mount Cook. Photograph by J Head, October 3, 2018 f=50.

16. This stretch of the lakeshore is the busiest due to the presence of SH8 which provides the ‘main highway’ through the Mackenzie Basin. Along this stretch of SH8 there are numerous scenic viewing locations – some formed and others less so. The primary viewing area along this stretch is located at the Pukaki information centre which includes a large car and coach park (Viewpoint 5). The lakeshore along here provides abundant photographic opportunities of the lake and Aoraki Mount Cook. Also located around this end of the lake are freedom camping areas near the junction of SH8 and Hayman Road amongst the trees. The ‘historic’ Pukaki Village Zone is located at the foot of the lake elevated on the terminal moraine. In addition to the above is an elevated viewing platform near the Pukaki dam and various tracks and picnic tables dotted along the lakeshore between SH8 and the lake. At any given day – particularly when weather conditions are favourable, many of these areas are inundated with sight-seeing visitors. From these areas, Aoraki Mount Cook is doubtless the primary attraction as it is seen with little foreground topography. The lake itself forms the foreground to the lake and in calm weather conditions when the lake surface is glassy, Aoraki Mount Cook can appear to be resting on a ‘mirror’ of sorts (Viewpoint 5 above).

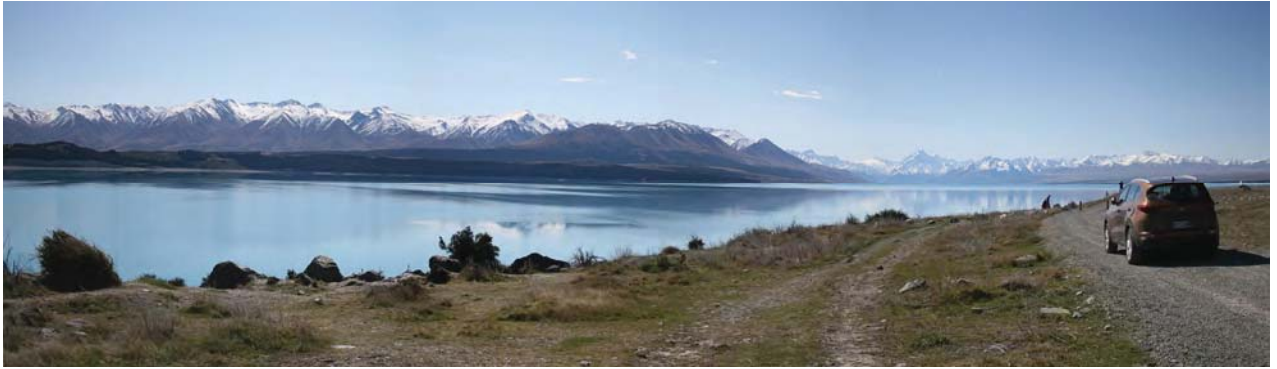
Viewpoint 6 View northwards up the lake from popular formed pull off from SH8. Photograph by J Head, October 3, 2018 f=50.

17. Around the southern end of the lake the topography grades down to the lakeshore in places – including where there are some existing vehicle access/freedom camping areas. Leaving the main highway and accessing public areas around the southern end of the lake is easier than it is along the western side of the lake (except for Peters Lookout). For this reason, the lakeshore is more heavily used, and for longer periods of time, often for picnics, short walks and such like activities (Viewpoints 6, 7).

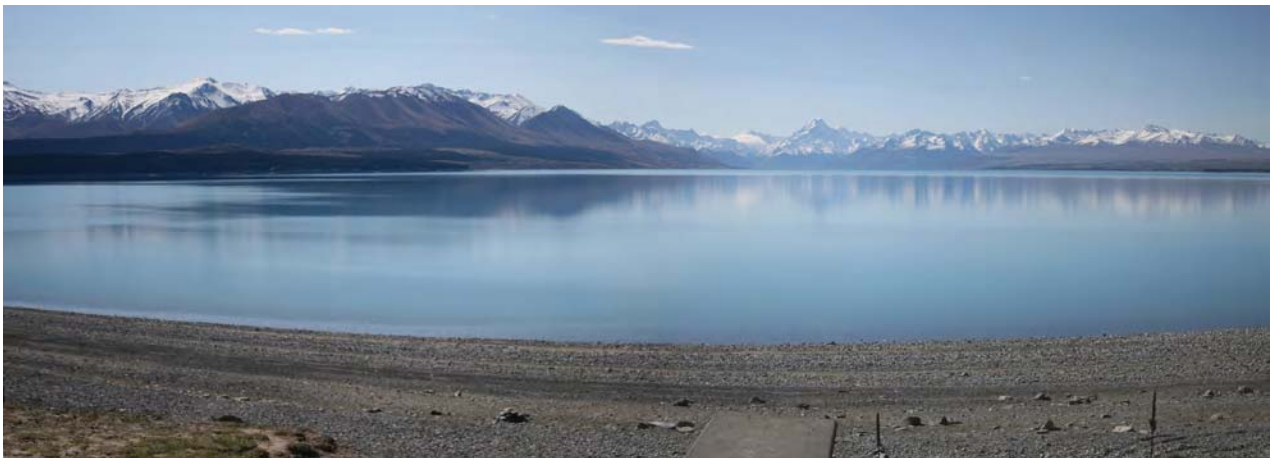
Viewpoint 7 View northwards up the lake towards Aoraki Mount Cook from one of several picnic areas (picnic table partially obscured in foreground). In these tranquil, clear conditions the lake and mountain connection is highly apparent. Photograph by J Head, October 3, 2018 f=50.

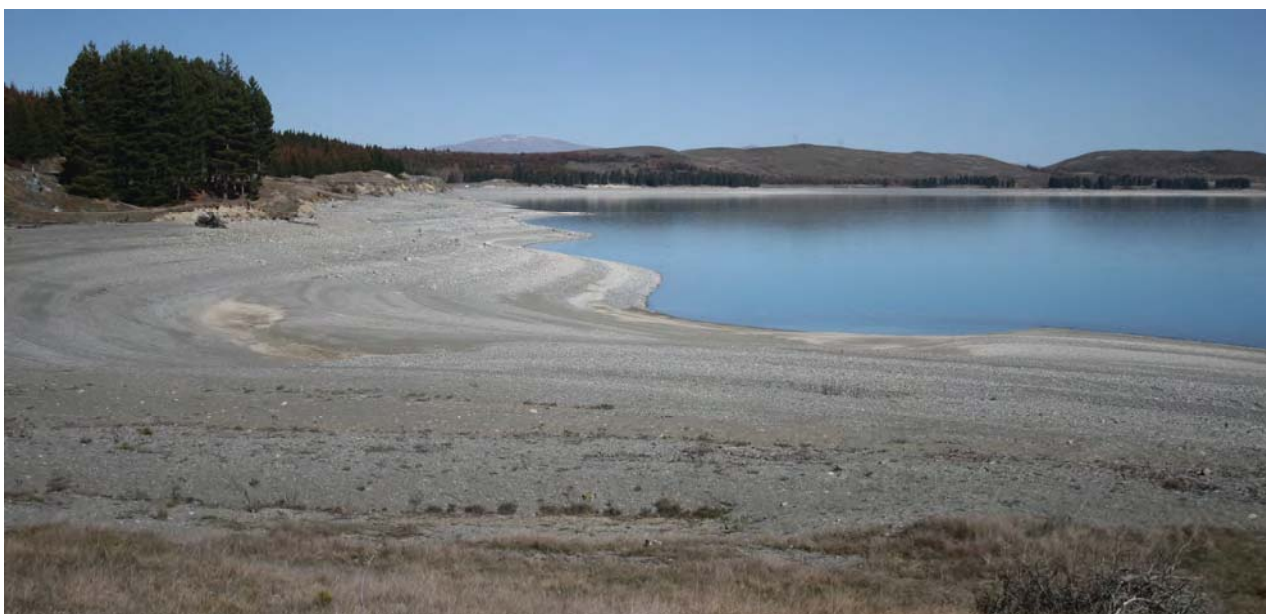
Viewpoint 8 View southwards from near 'The Pines'. Note gentle gradient down to lake over gravel beach. Photograph by J Head, October 3, 2018 f=50.

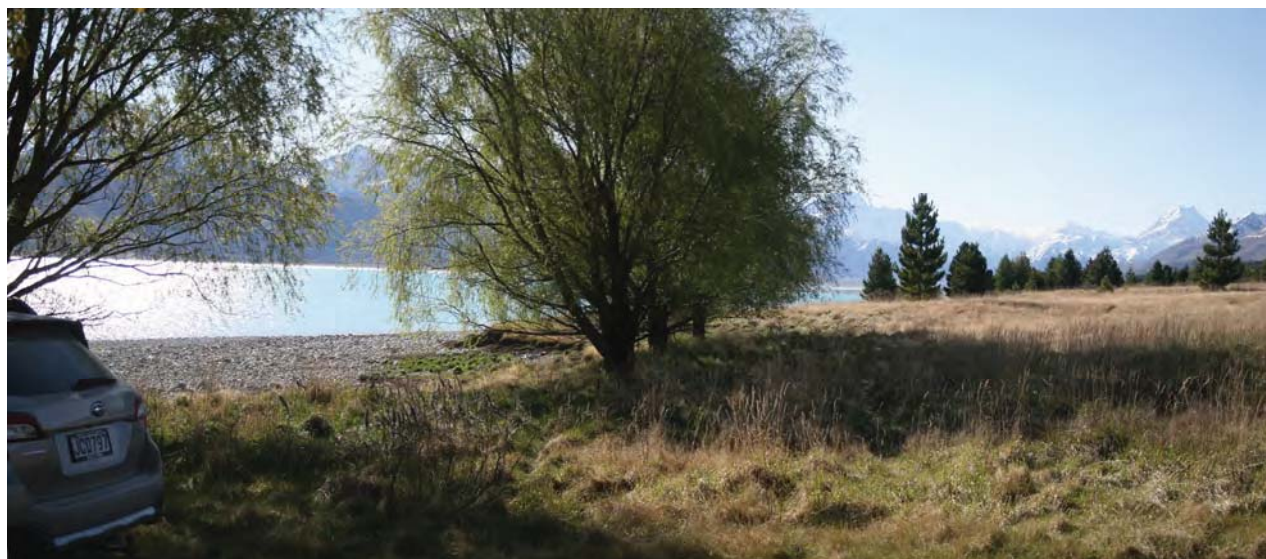
Viewpoint 9 View northwestwards from near Hayman Road (at right outside frame). Note gentle gradient down to lake amongst shade trees. Photograph by J Head, October 3, 2018 f=50.

21. There are some areas where public access to the lake has been formed via short narrow gravel tracks amongst the trees. One such area has a toilet. In other areas the lake access is not formed, but is relatively easy to achieve in a 4WD vehicle (Viewpoint 9). And in other areas such as The Pines, it is easy for most vehicles to access the edge of, if not onto the lakeshore beach itself. The locations of these potential/existing lake access points are indicated in **Appendix 1**. During my field work I did not see any evidence of jetties or boat ramps, although there were parts of the lakeshore that were screened by trees where such structures could possibly be found.

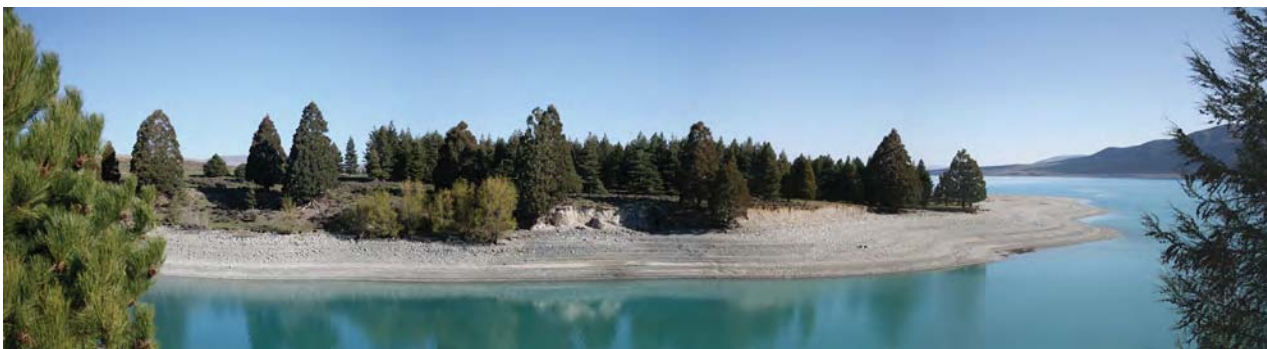
Viewpoint 10 View southwestwards into embayment near Boltons Gully from Hayman Road. Note gentle gradient down to lake amongst trees on opposite side, and potentially sheltered cove. Photograph by J Head, October 3, 2018 f=50.
