Tekapo Landco Ltd

**Lake Tekapo Holiday Park
Geotechnical, Ground Contamination,
and Services Capacity Assessment**

June 2014

T&T Ref: 53436

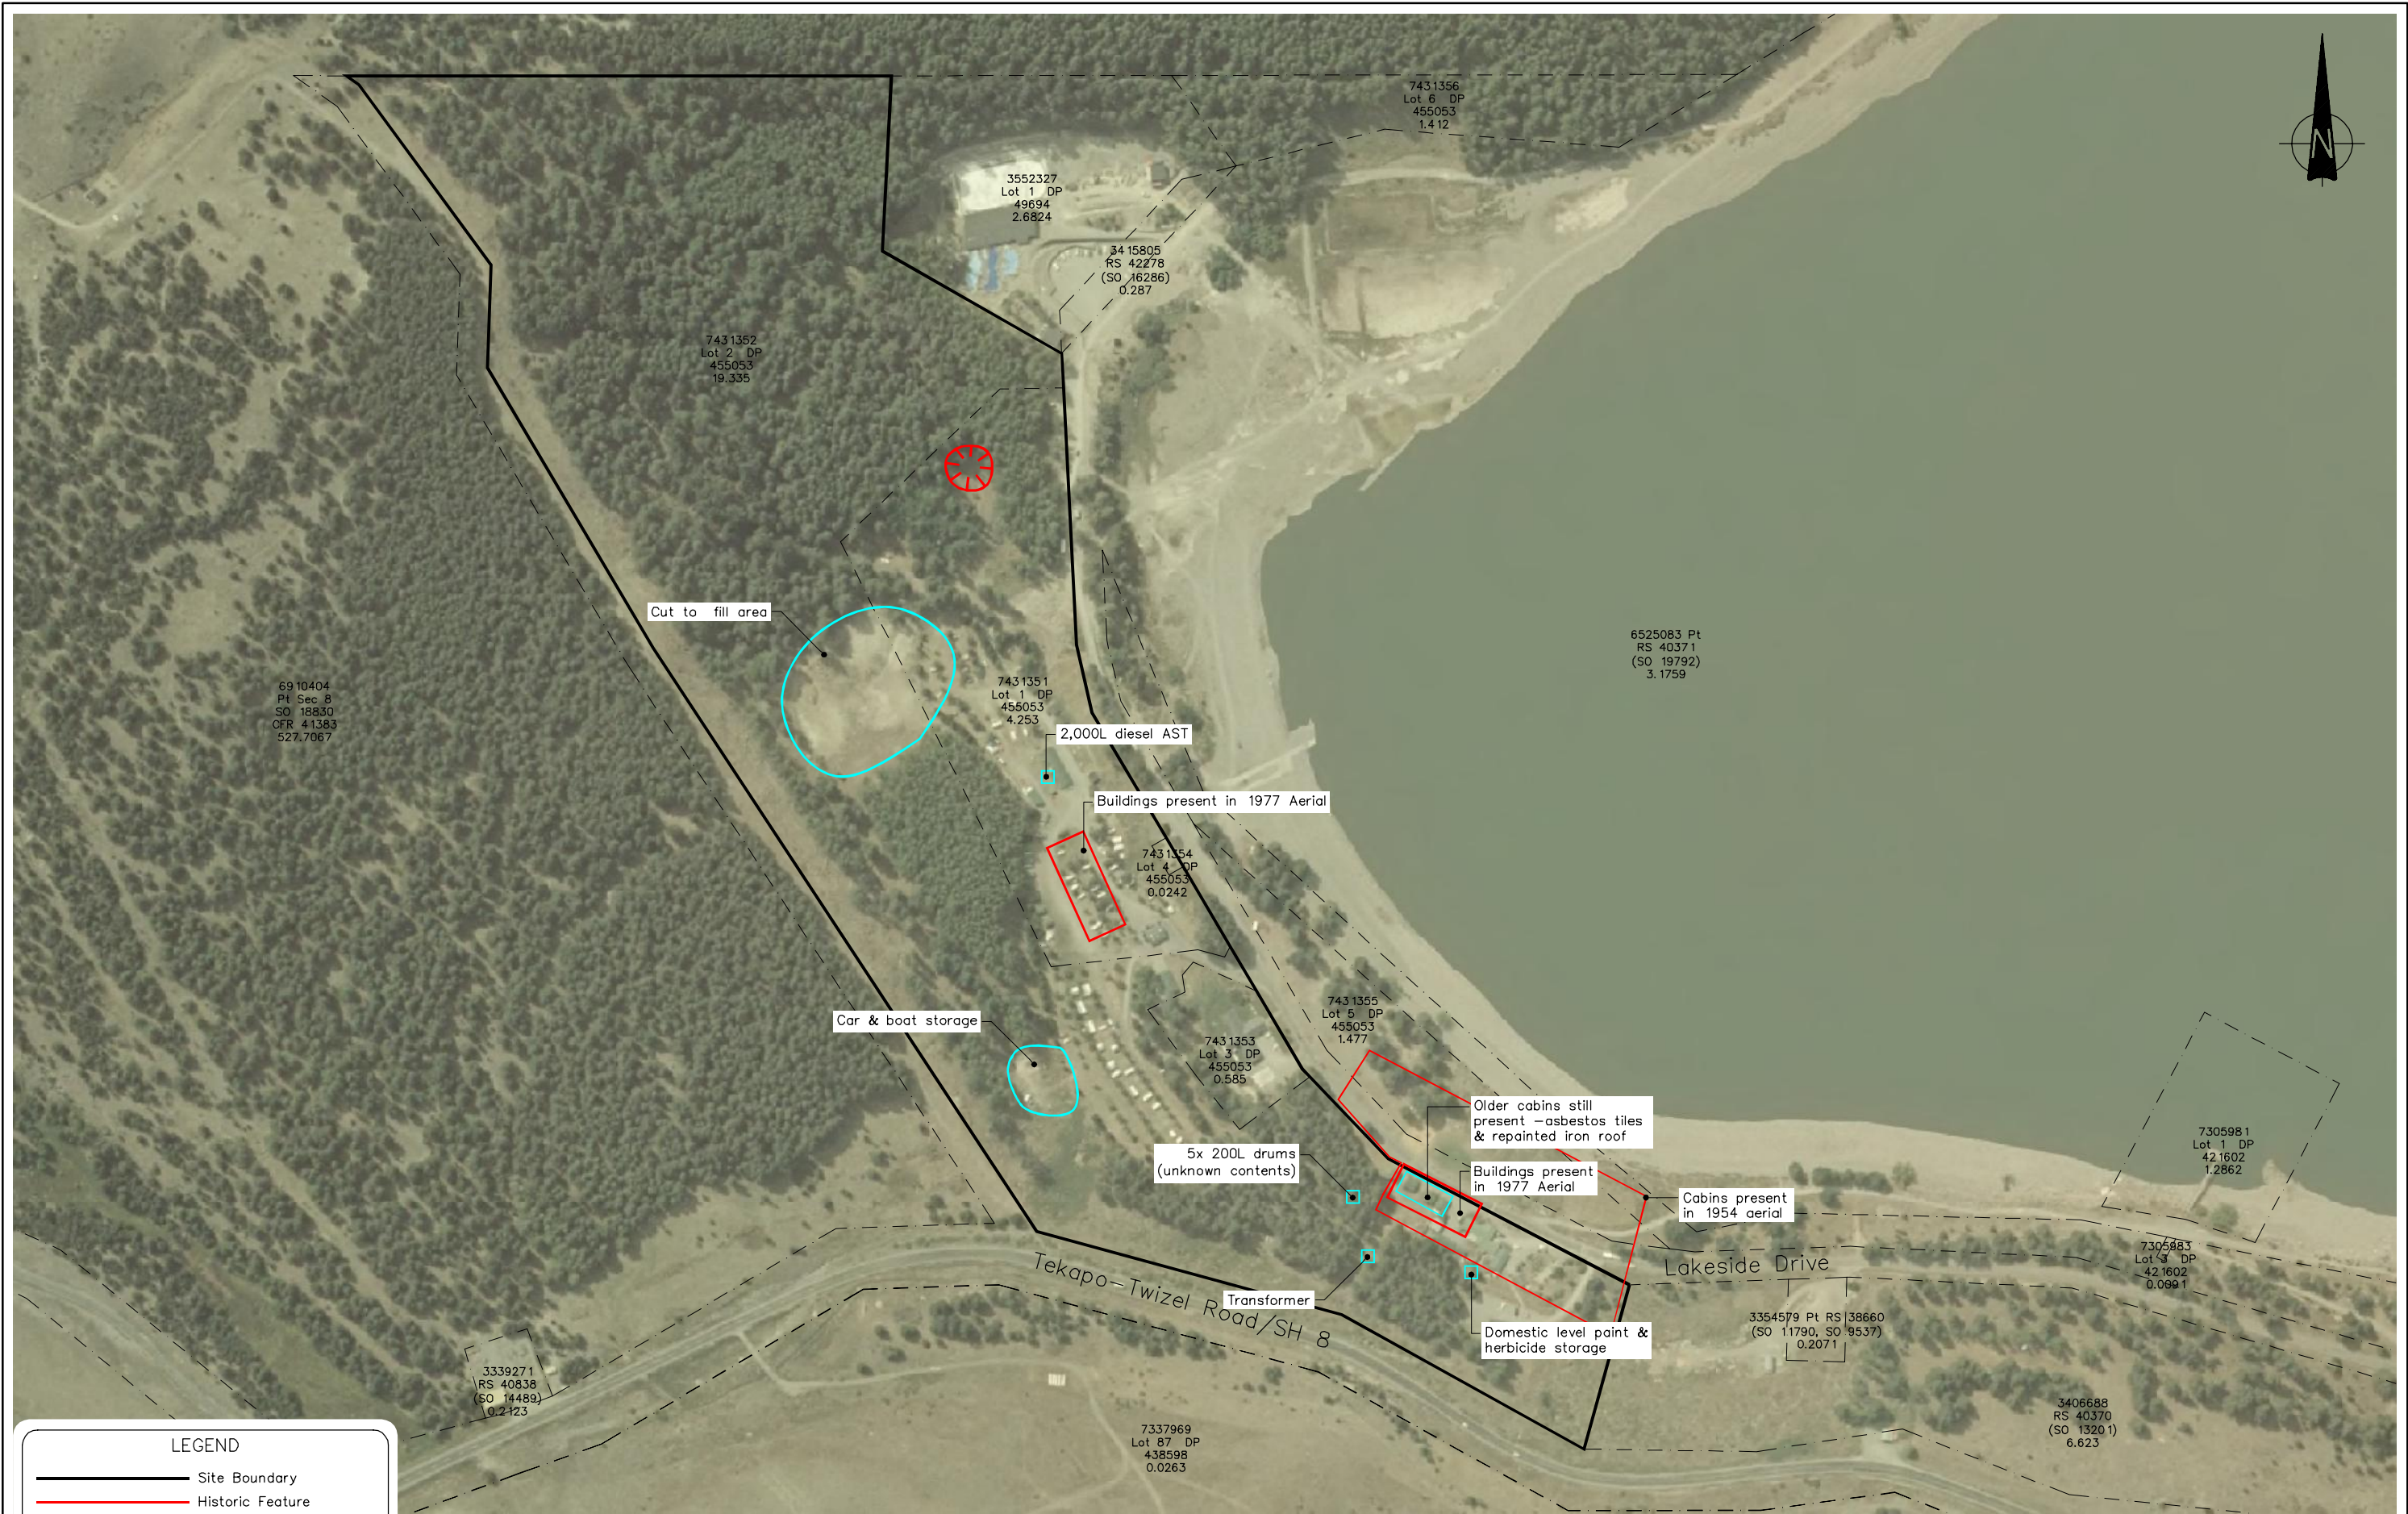
FIG. No.	53436-F2	REV.	0
----------	----------	------	---

A walkover inspection was carried out on 25 February 2014 by a T&T Senior Engineering Geologist. Key site features relating to the potential for ground contamination are summarised below and shown on Figure 2 in Appendix A.

- The older cabins (identified in Figure 2) have corrugated iron roofing that was recently repainted and asbestos tiles used in gable ends;
- A 2,000L diesel above ground storage tank (AST) is located in the camp ground for heating water (shown in Figure 2). The tank is surrounded by a concrete block bund and appears to be in good condition;

Historical information relating to the site has been collected from a variety of sources. The information presented documents on-site activities, except for the aerial photograph review where comments are also provided on readily observable surrounding land use. The site features are shown on Figure 2, Appendix A.

The area west and north of the camp ground, which is the subject of this report, was observed in a site walkover on 25 February 2014. Exposure of till deposits was observed in several man made cuts around the perimeter of the camp ground. There was no indication of slope stability or active erosion across the area. A subdued expression of ground subsidence (possible kettle hole³) was observed on the lower slopes to the north of the camp ground (see Figure 2). Development over or adjacent to (i.e., within 10 m of) the kettle hole should not occur without investigation of the feature to ascertain if there is ongoing or future risk of subsidence.

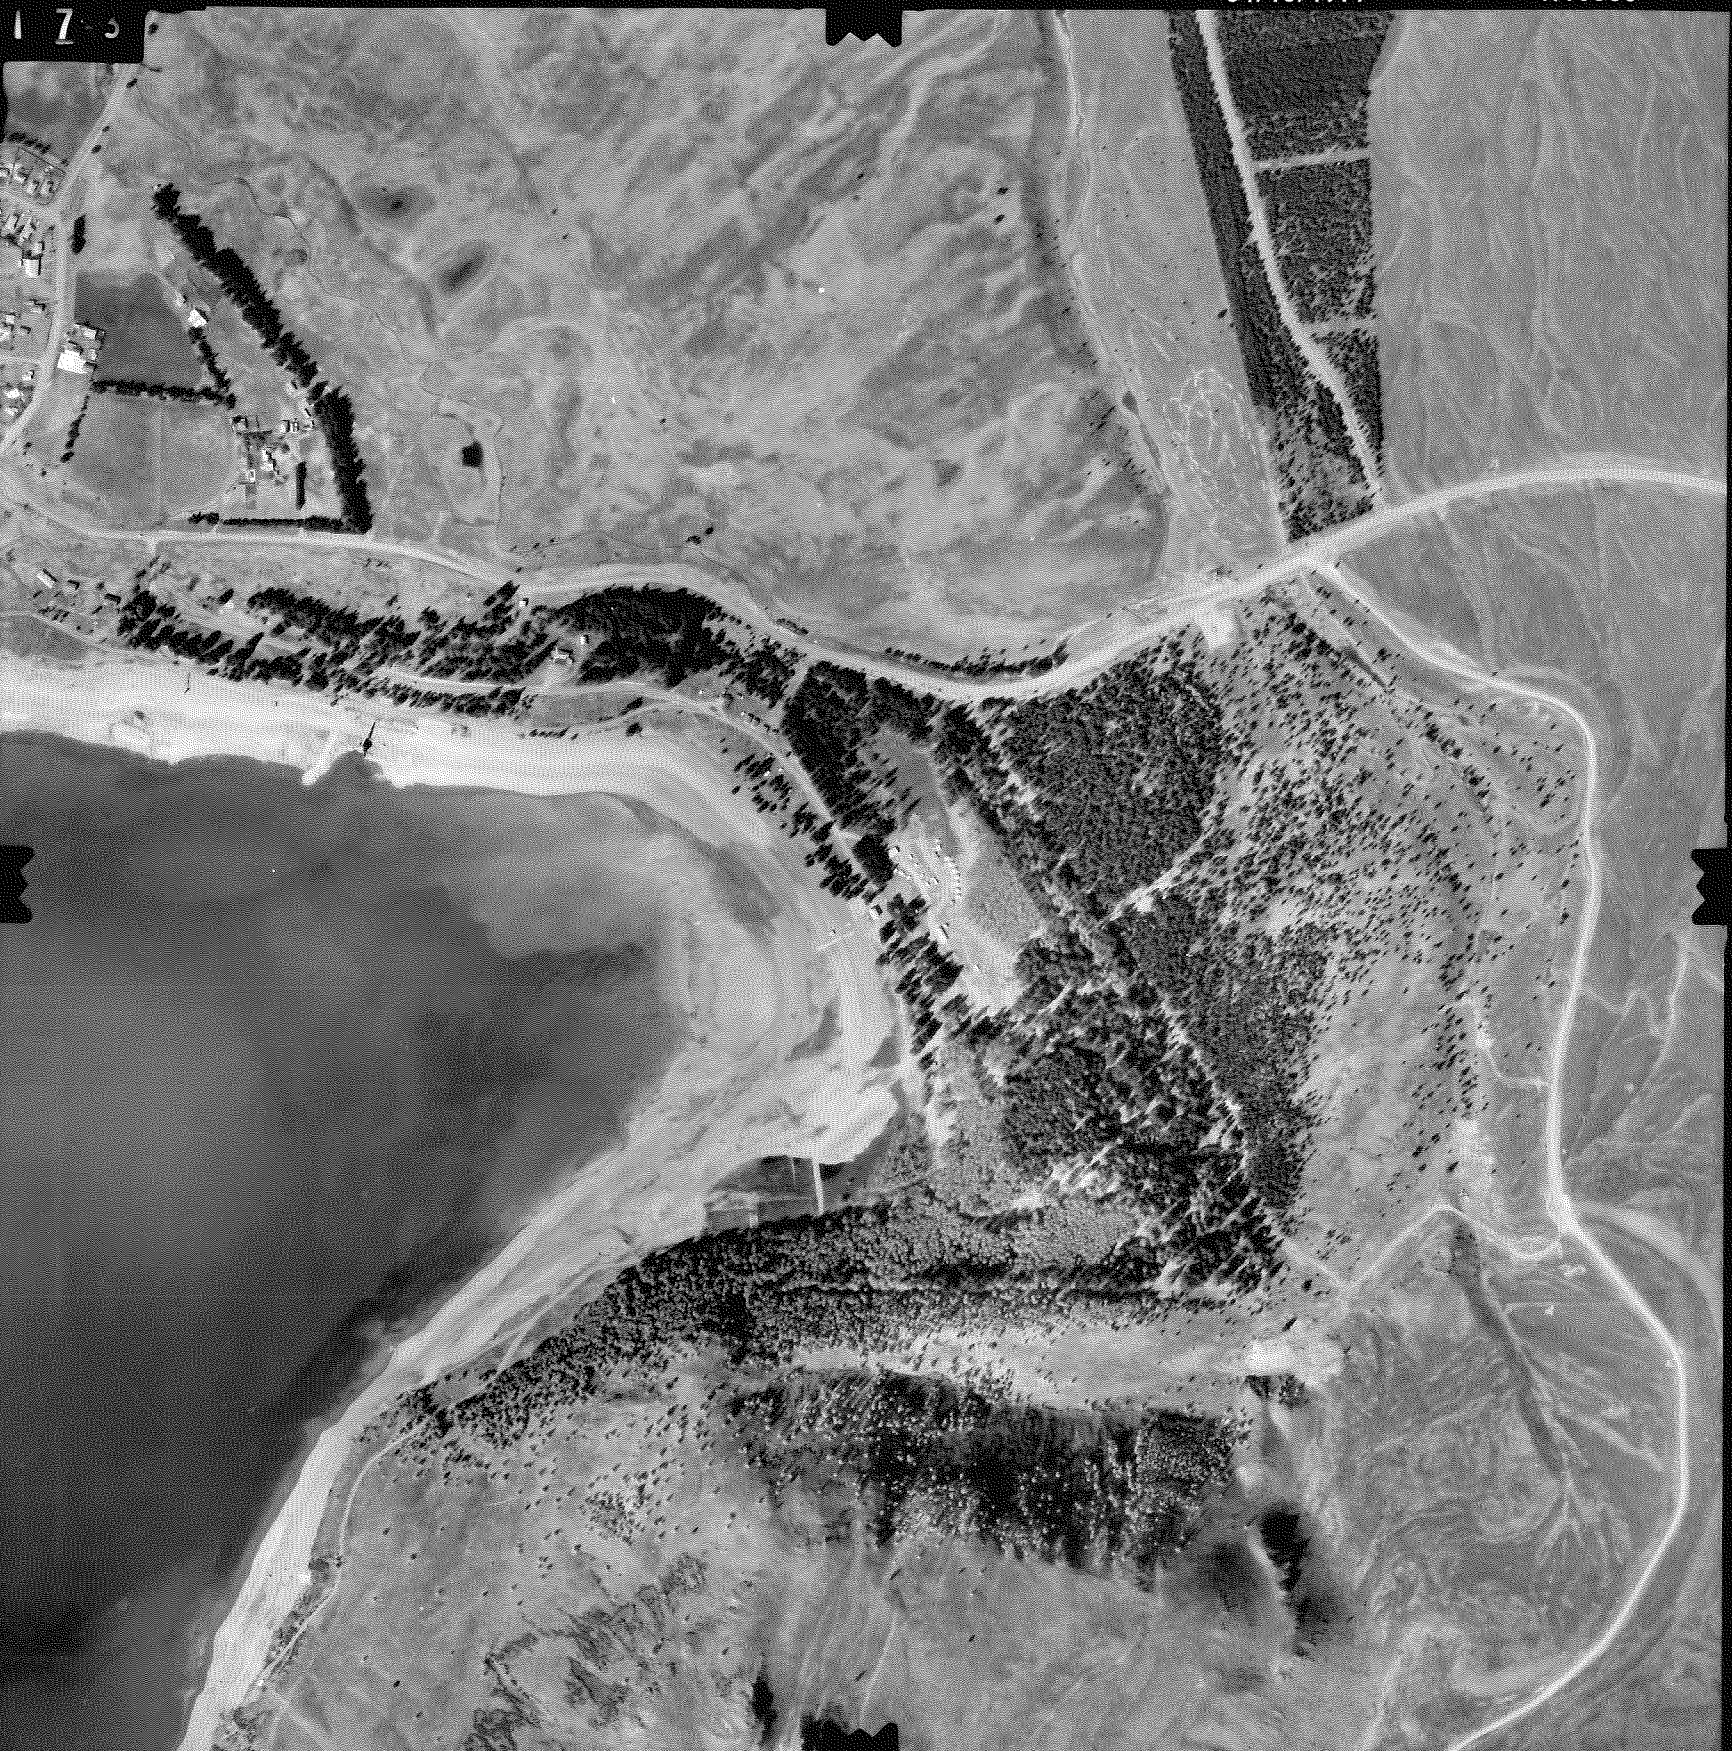
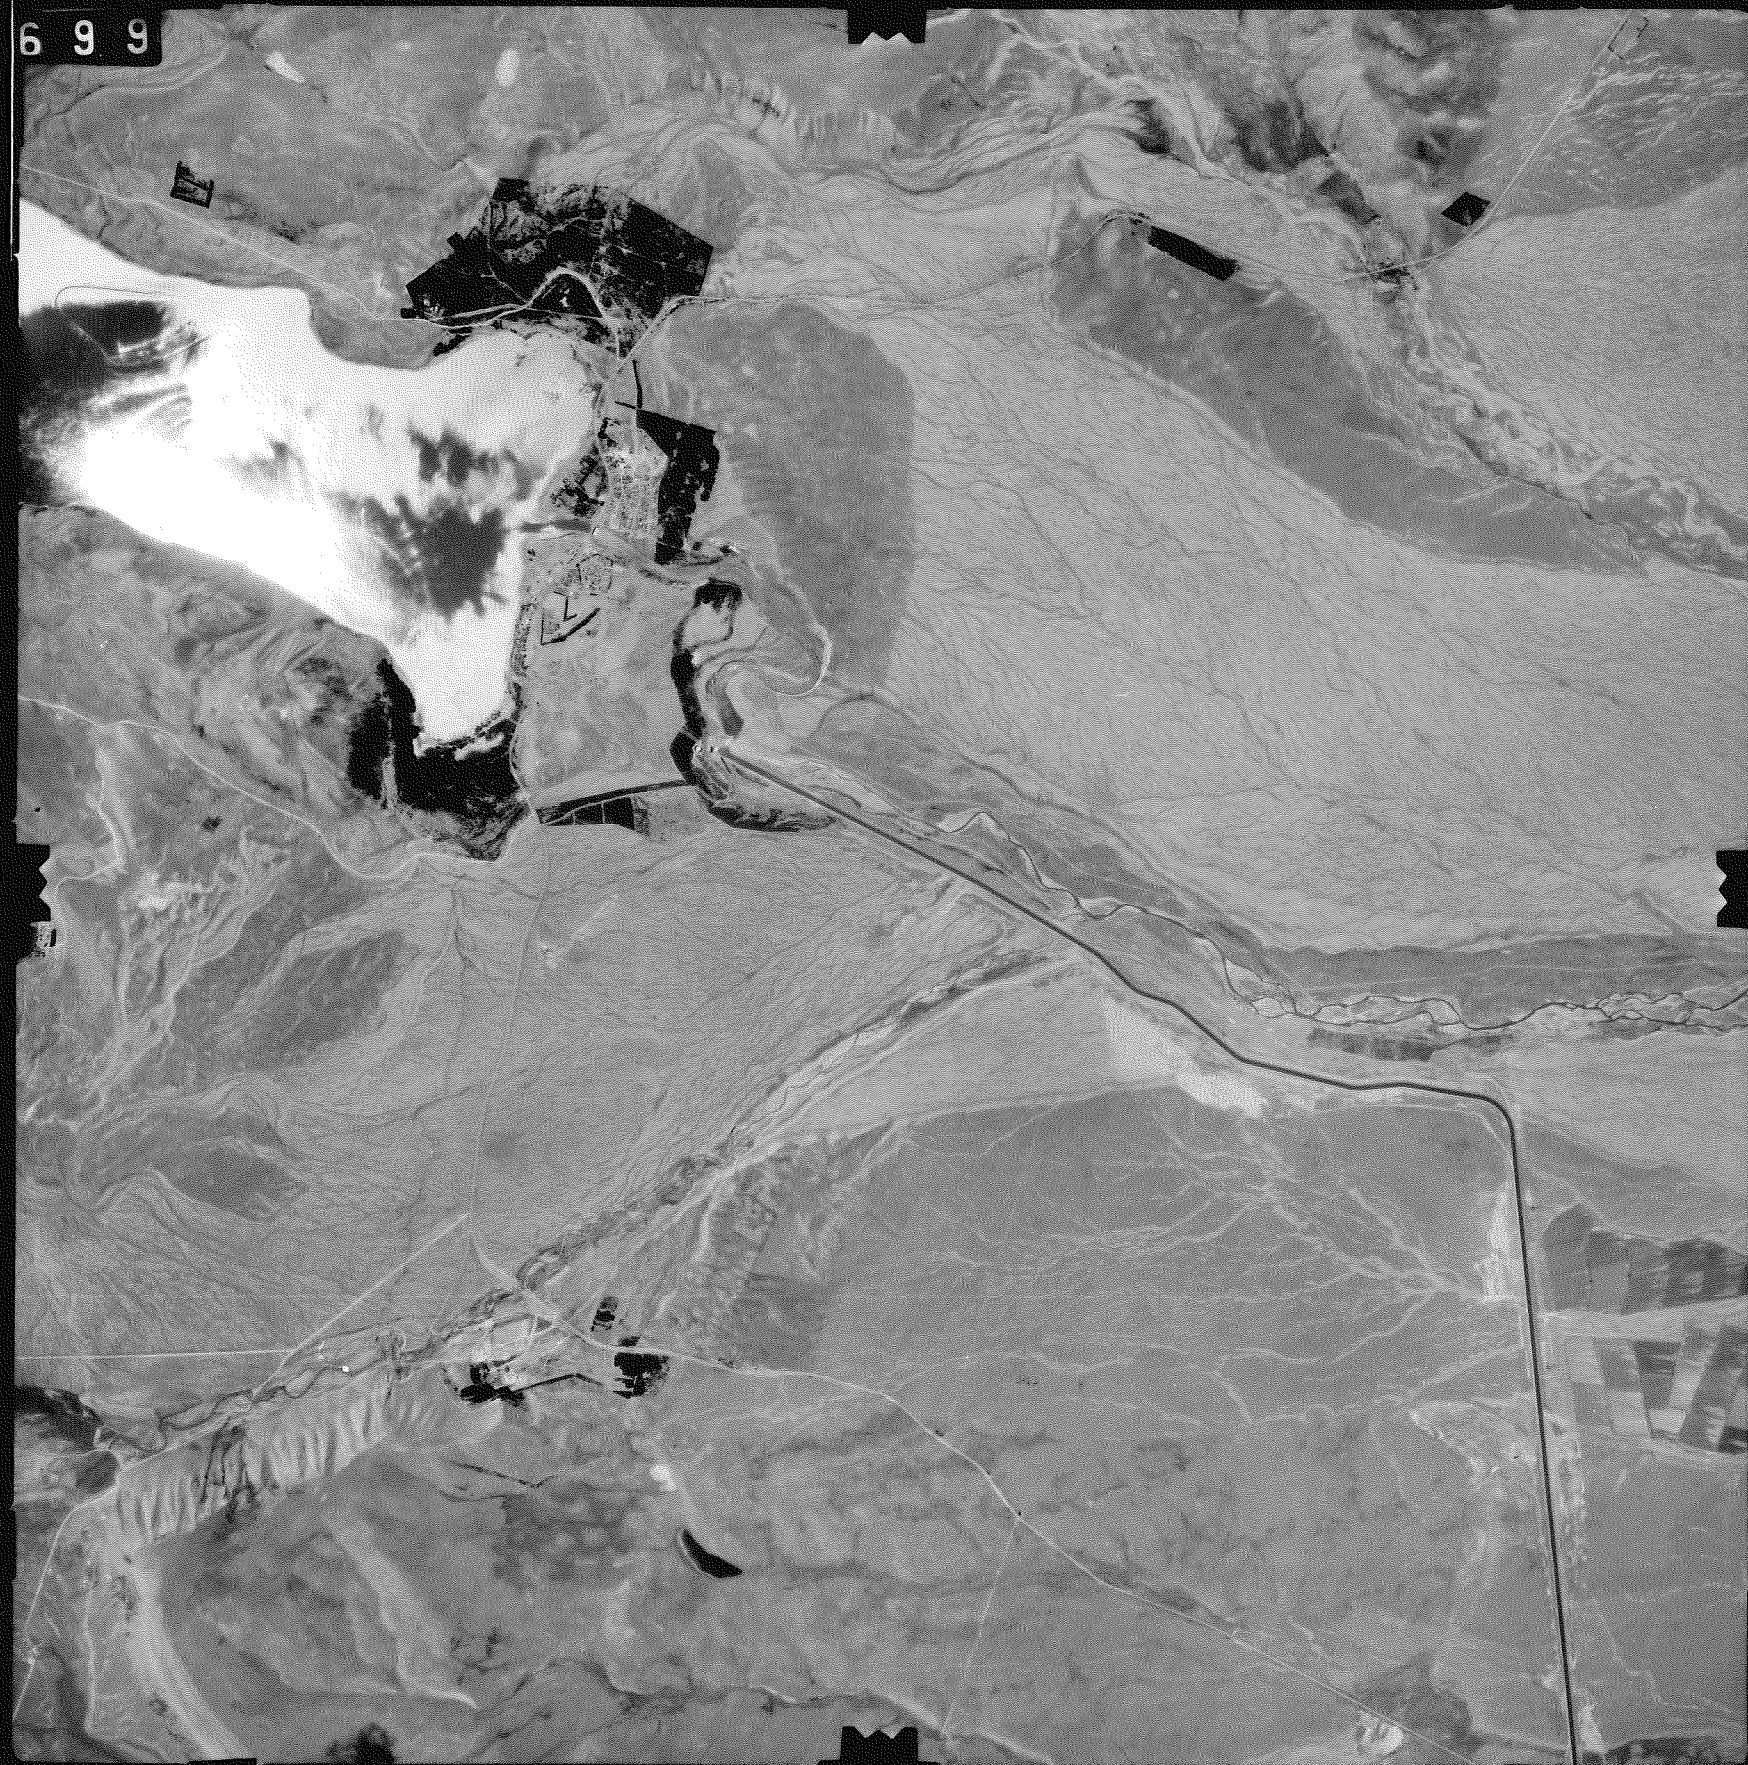
Historical aerial photographs from the T&T library and other sources have been reviewed as stated in Table 2. Relevant features of the site and surrounding land are summarised from each aerial photograph in Table 2. Copies of the aerial photographs are included in Appendix B.

Date and source	Key site features	Surrounding land features
1954 NZAM	The site appears to be largely covered in forest and scrub. The south eastern portion	Lake Tekapo is present to the east and some forested areas with a couple of dwellings

Date and source	Key site features	Surrounding land features
	of the site has approximately 14 cabins present.	present to the south east of the site. The remaining areas are rural.
1977 NZAM	Four cabins visible in the 1954 aerial are still present and a dwelling has been constructed near the cabins. An area of forest/scrub, centrally located, has been cleared and cabins have been developed.	The forested area has extended further west of the site. There are no other significant changes in the surrounding land use.
1986 NZAM	Due to scale of the photograph, it is difficult to distinguish small features. There appear to be no significant changes to the site.	There appear to be no significant changes to the site.
2006 Google Earth	More cabins have been developed across the site.	The area to the north east of the site has been cleared (for Tekapo Springs development). There are no other significant changes to the site.

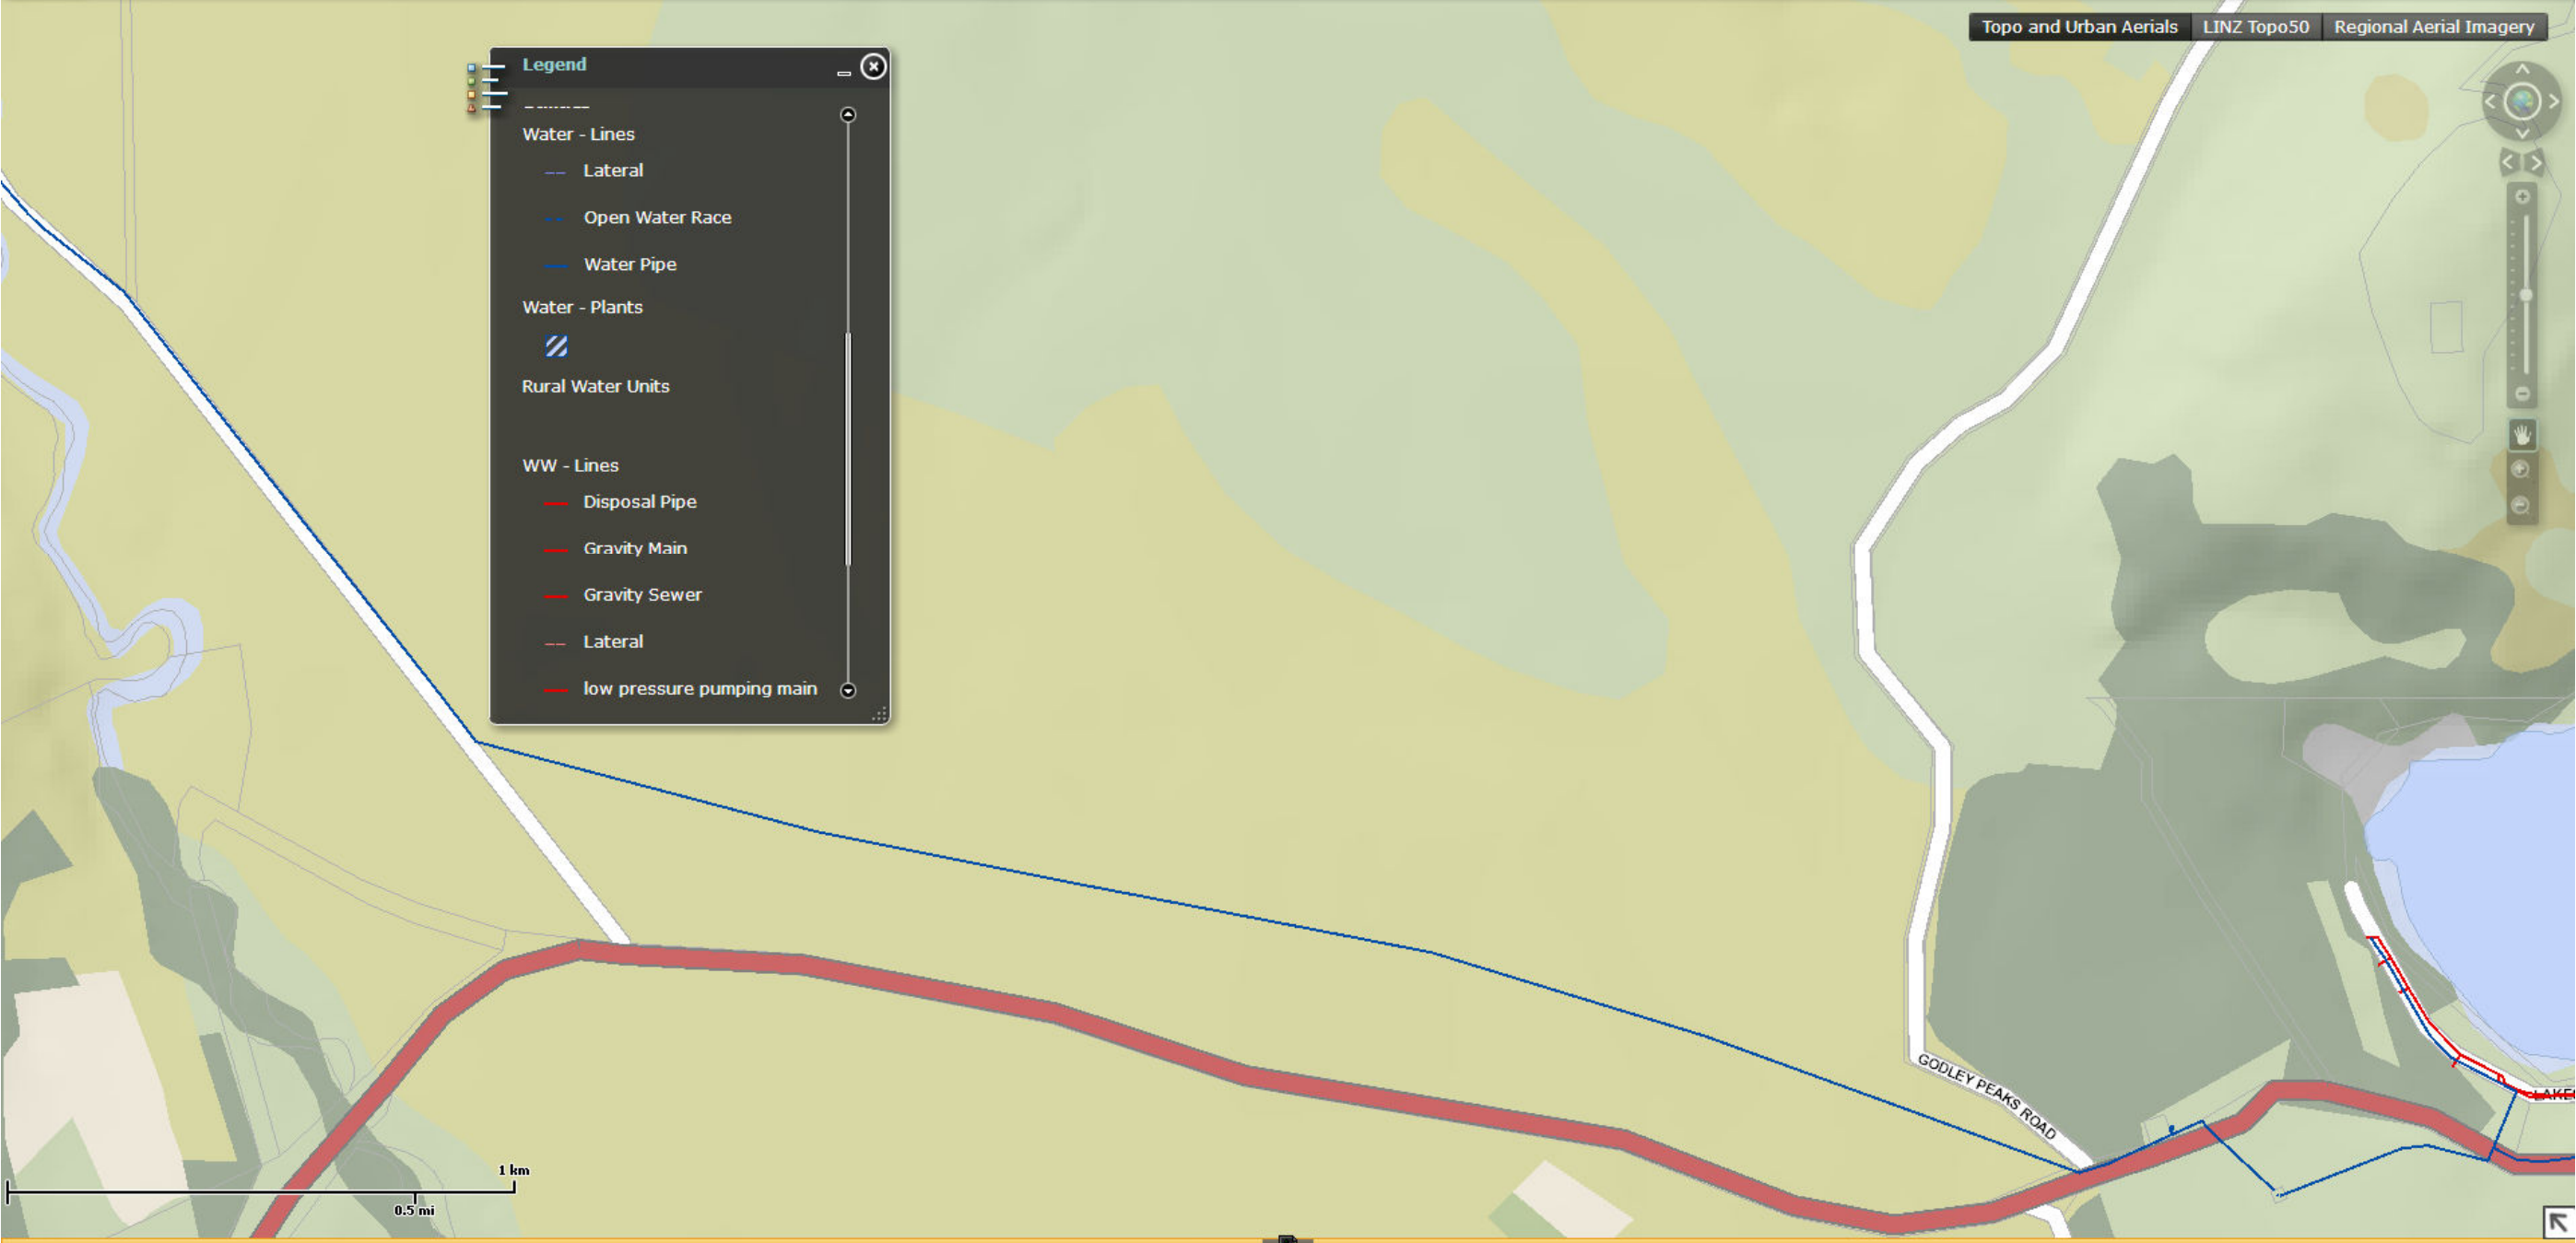
- Water - Lines
 - Lateral
 - Open Water Race
 - Water Pipe
- Water - Plants
- Rural Water Units
- WW - Lines
 - Disposal Pipe
 - Gravity Main
 - Gravity Sewer
 - Lateral
 - low pressure pumping main
