Ohau A Reservoir – Dam-Break Inundation Maps for Emergency Management

Prepared for Meridian Energy Limited

Issue 2

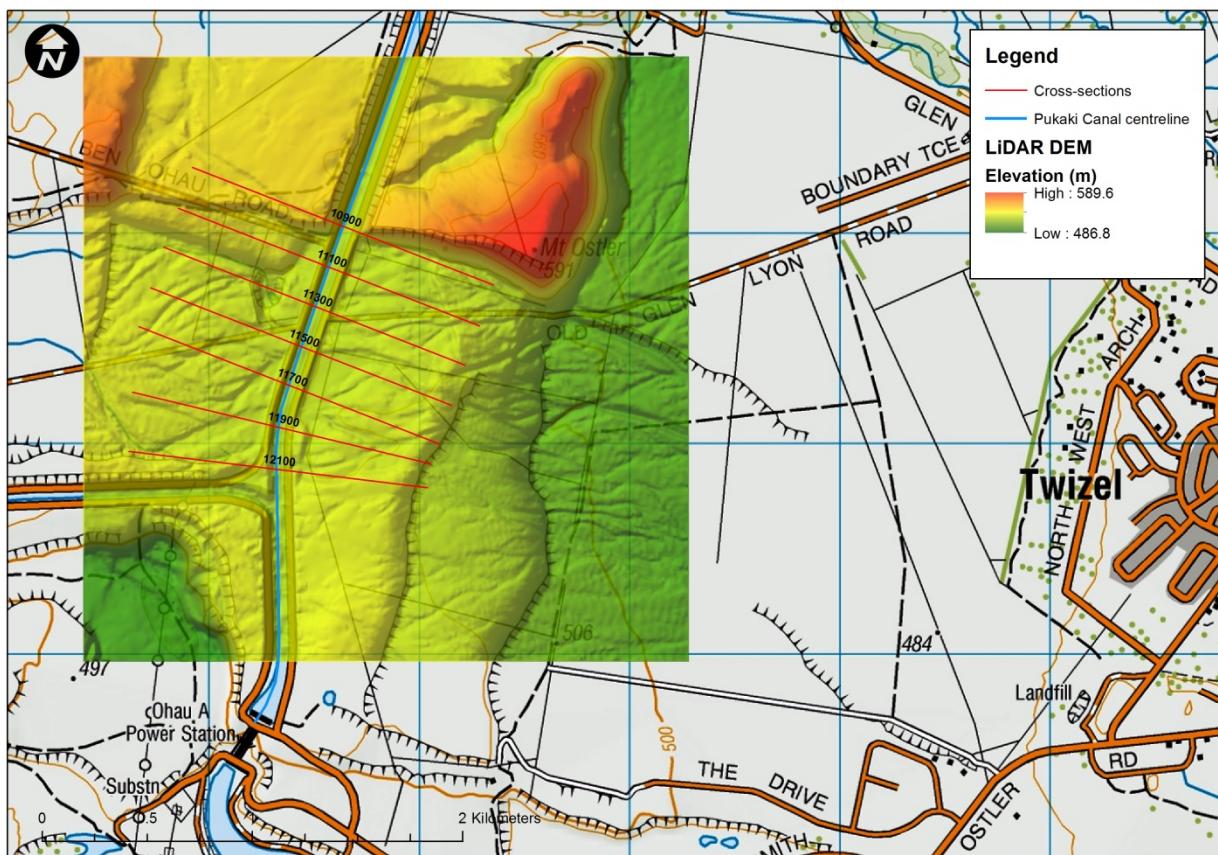
Figure 1 – Location of cross-sections and LiDAR Digital Elevation Model (DEM). Pukaki Canal flow is from north to south.

Figure 1 shows a plan of the Pukaki Canal from chainage 10,900 to 12,000 m overlain with a digital elevation model developed from 0.5 m contours derived from LiDAR aerial survey data

flown in 2012. Cross-sections, at locations shown on Figure 1, have been extracted from the digital elevation model and shown in Figure 2. Note that LiDAR aerial survey does not penetrate water surfaces and the submerged profile is shown with a dashed line in Figure 2.

The true left bank of the canal between approximately chainage 11,000 to 11,900 m has embankments up to 2.5 m above natural ground level. However, the maximum canal operation level is only around 0.2 m above natural ground level.

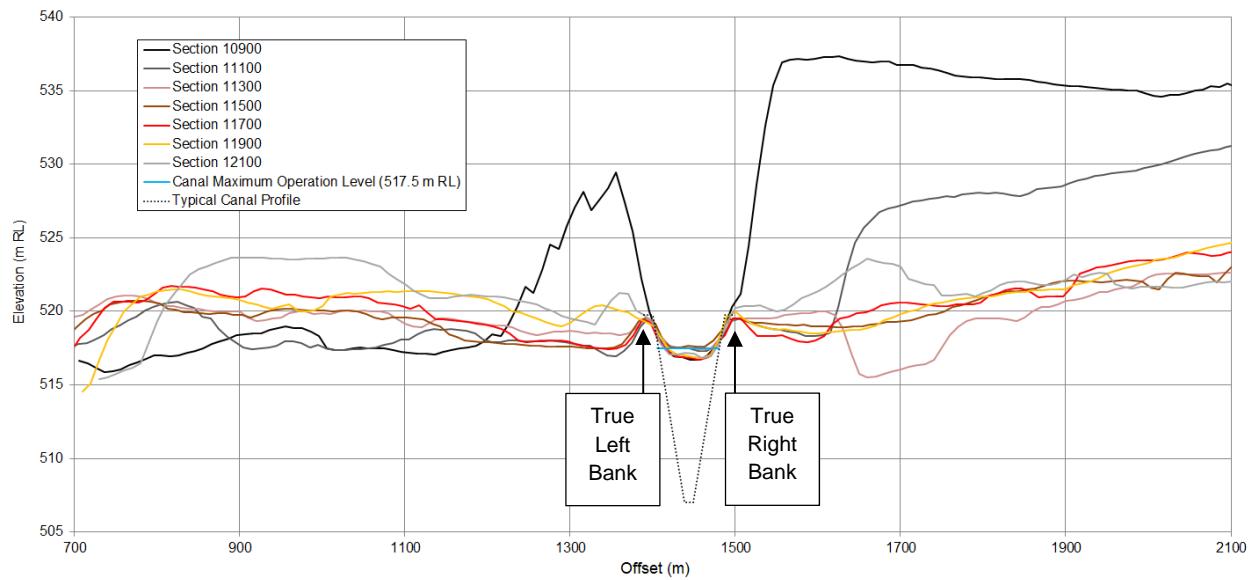
Figure 2 – Cross-sections

Figure 2 illustrates that natural ground level on the true right bank of the canal is above the maximum canal operation level of 517.5 m RL² with no potential for release of canal water. An exception is at cross-section 11,300 m where the ground level drops below 517.5 m RL approximately 1.5 km from the true right bank. However due to the significant distance from the canal bank this section does not have the potential to breach.

The maximum peak breach outflow from the true left bank of the canal between chainage 11,100 to 11,900 m is estimated with the Froehlich (1995) equation to be less than 5 m³/s. Such a discharge will produce a shallow overland flow with depths less than 0.3 m and would cause negligible flood hazard to downstream people or property.

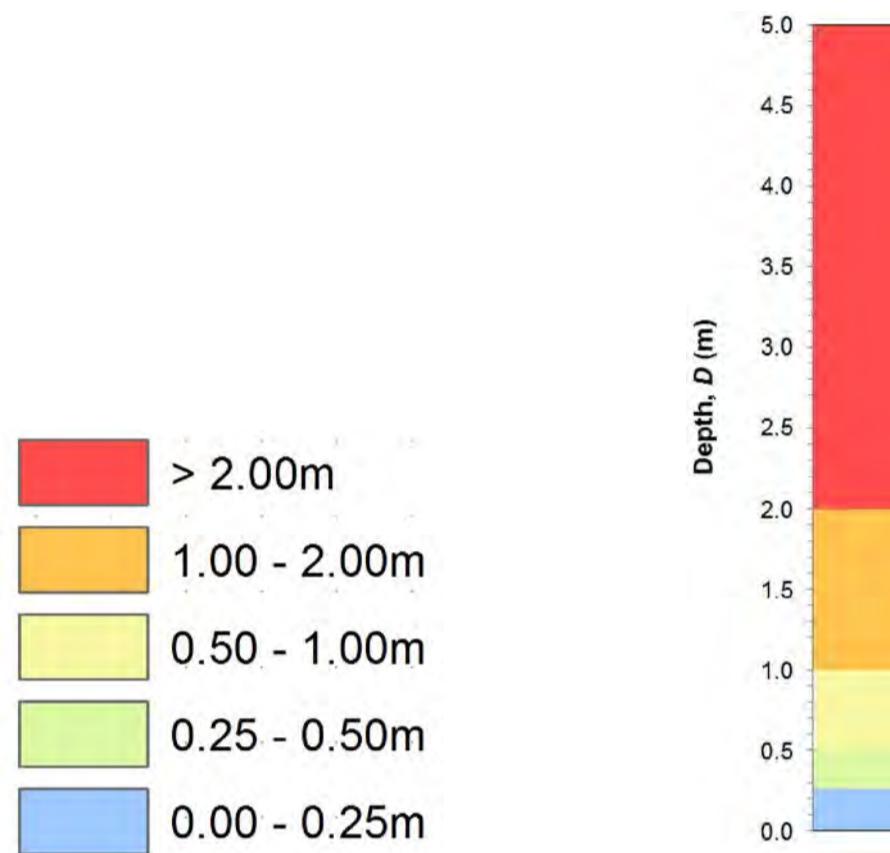
Figure 1 - Maximum Flood Depth Bands

The maps show the maximum likely depth of flooding arising from failure of the **Ohau A Reservoir**. The maximum flood depth (above natural ground level) is shown in five bands as illustrated in Figure 1 and 2. Maximum flood depth is derived from computational hydraulic modelling results (refer to data sources below).

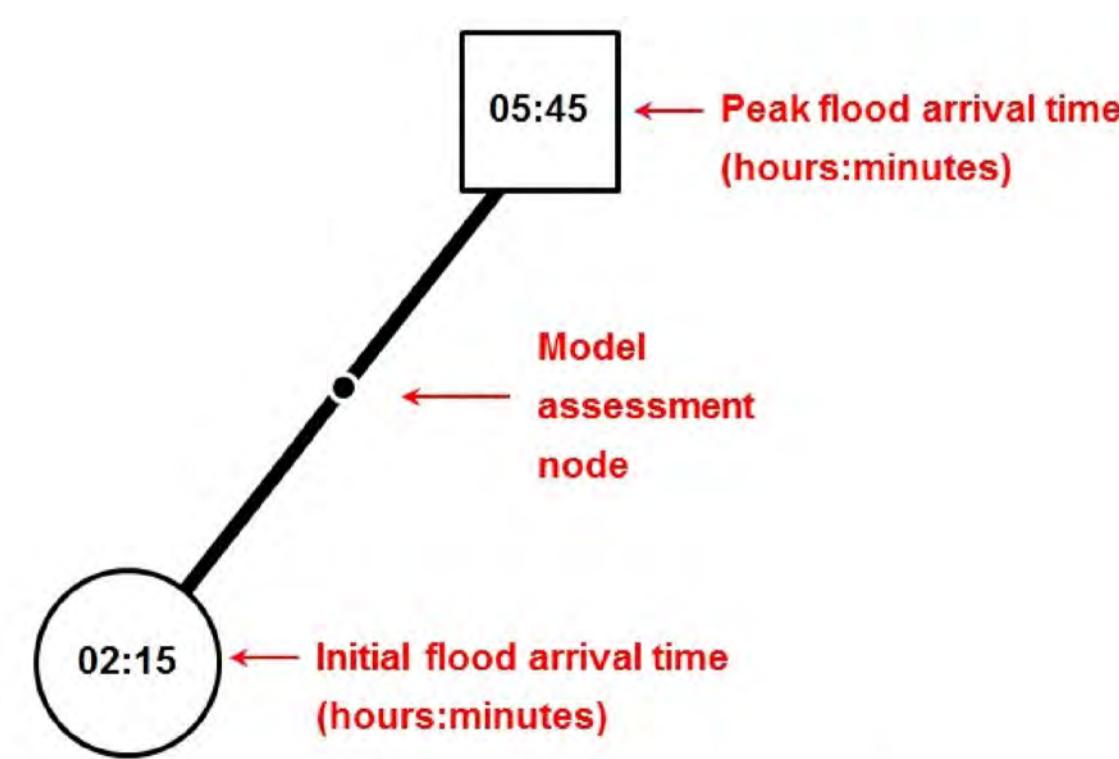
Figure 3 - Travel time information.

All flood wave travel times are measured from the onset of rapid failure of the dam.

Figure 3 illustrates how travel time information is provided on the maps. Travel times should not be interpreted as precise, but as an indication of the possible flood travel time for emergency planning.

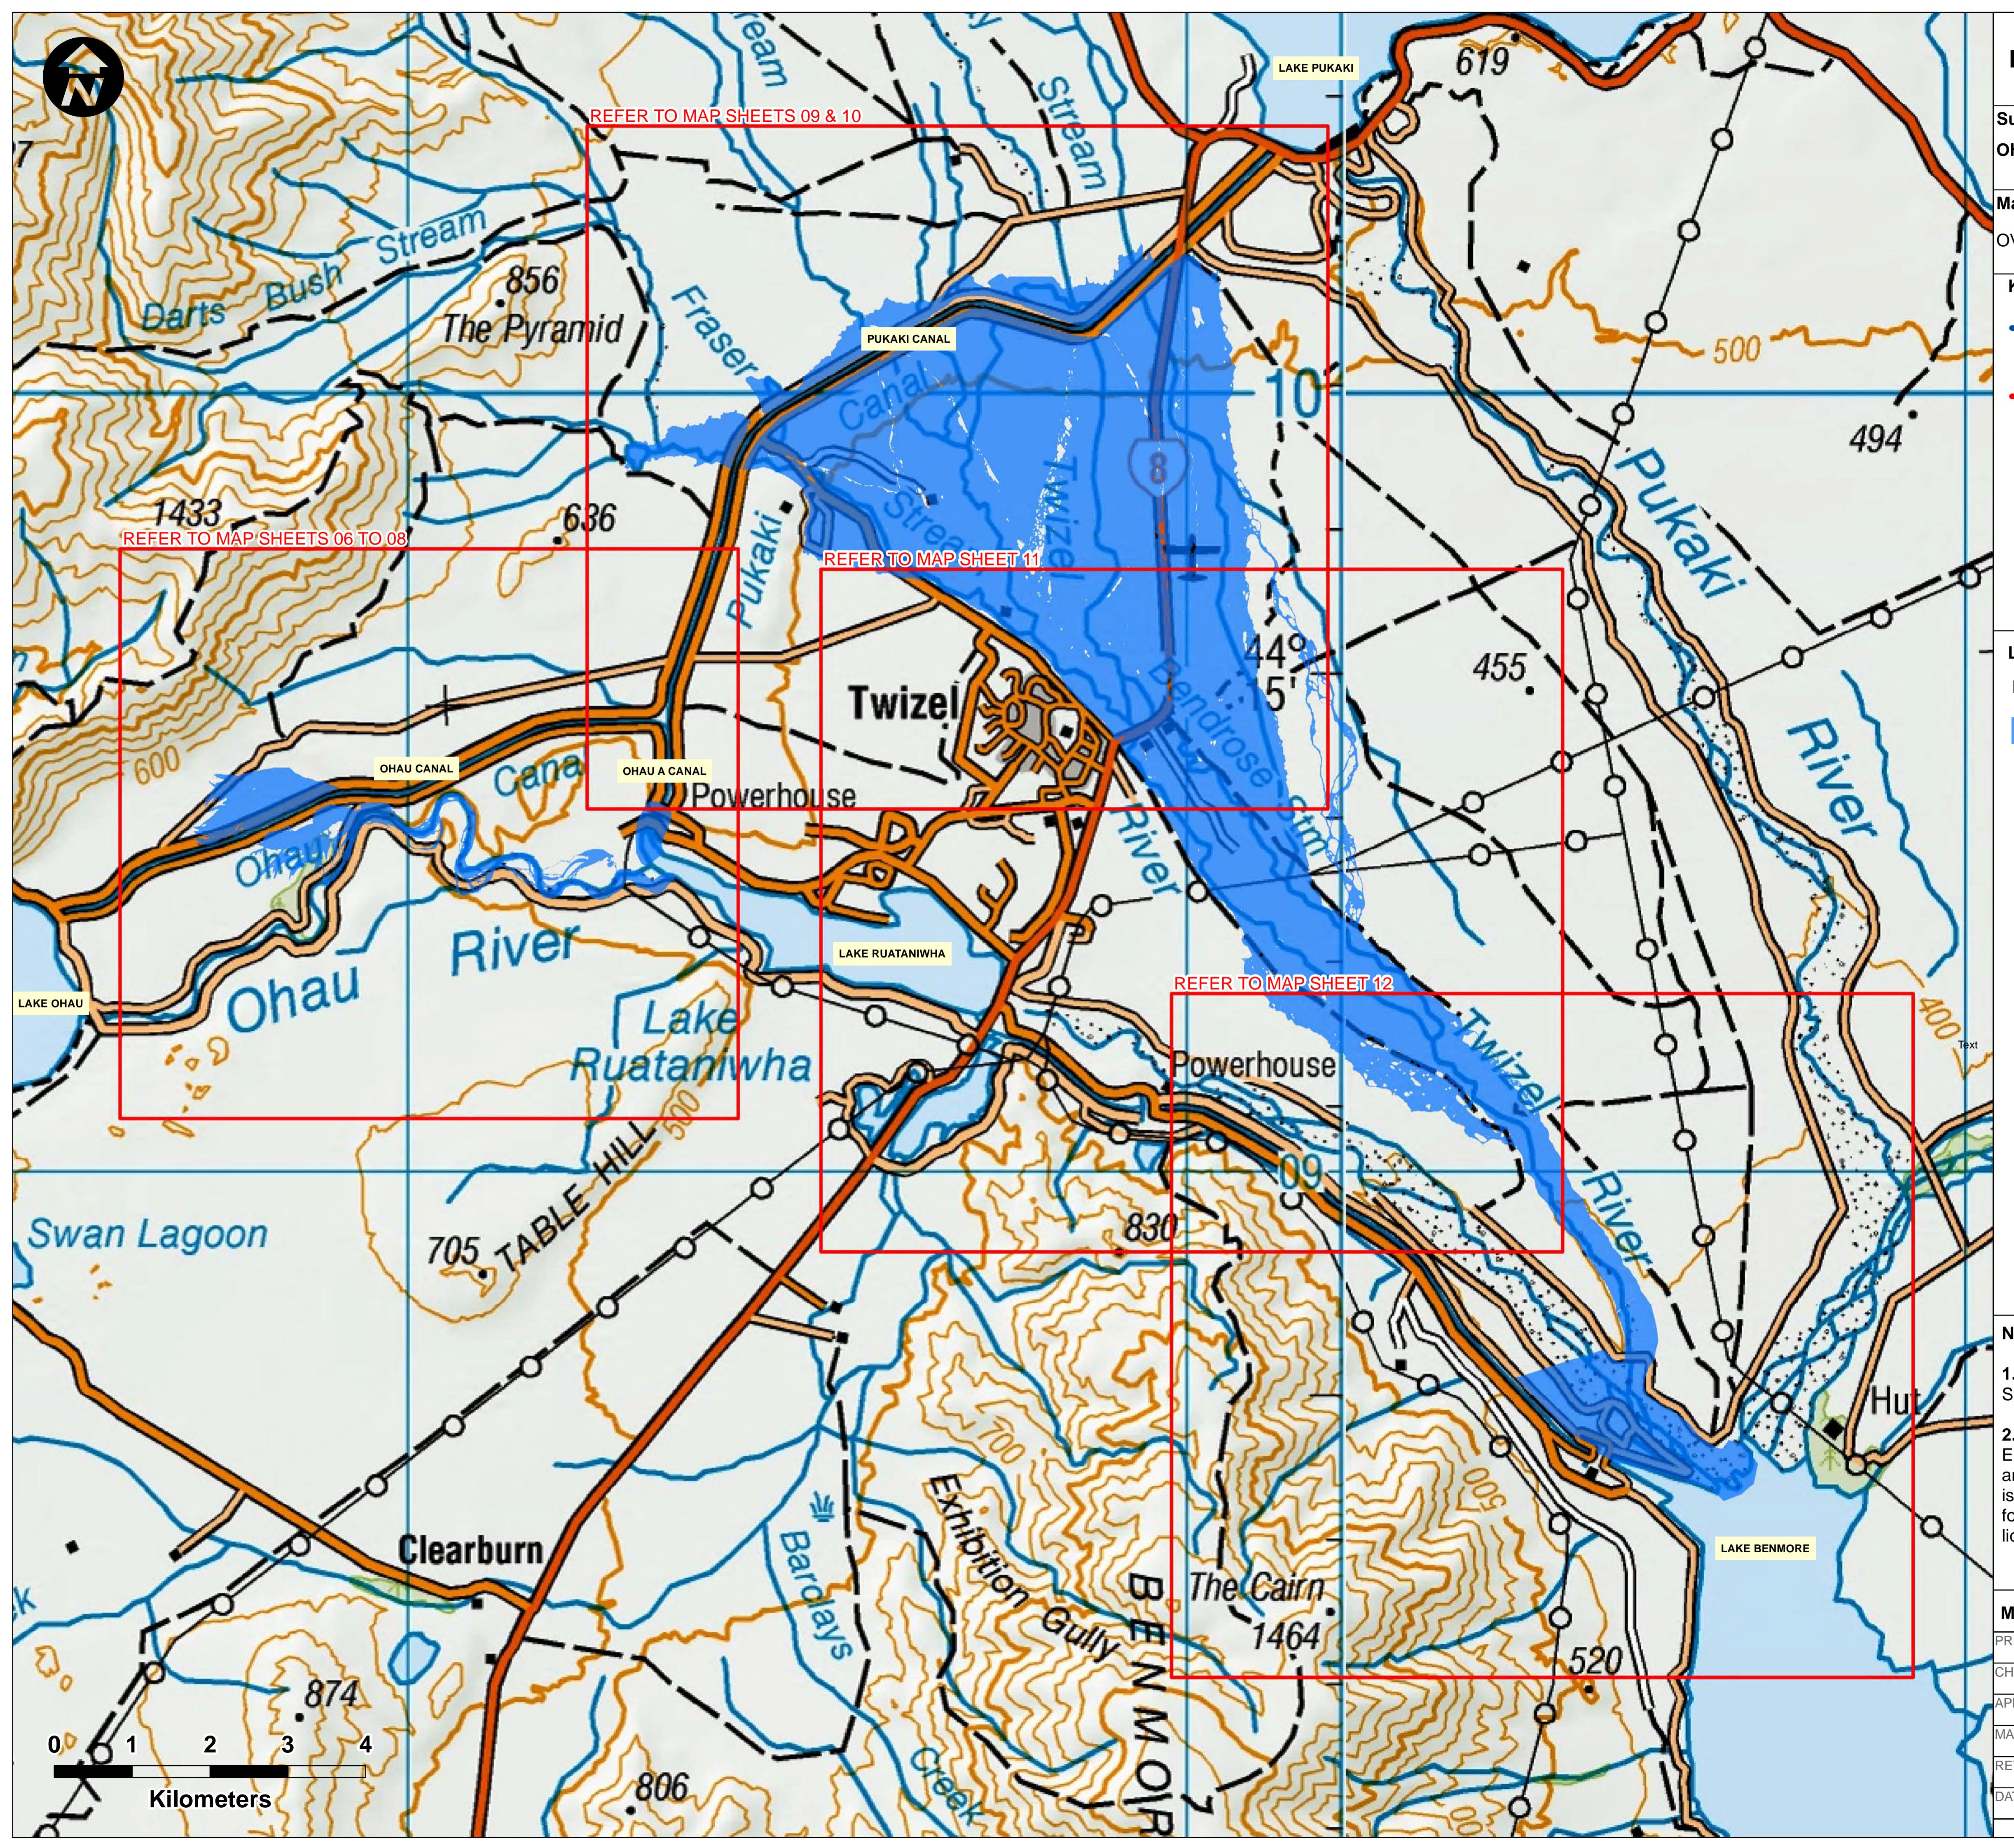
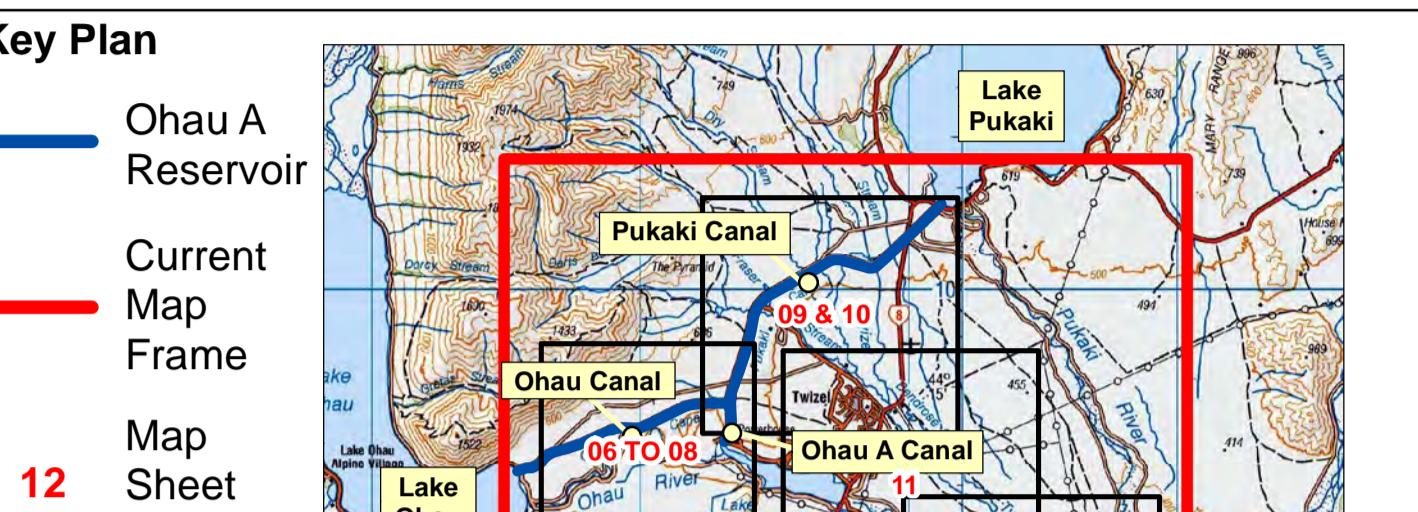
Subject Dam	Map Sheet No.
OHUA A RESERVOIR	05

Map Information
OVERVIEW MAP

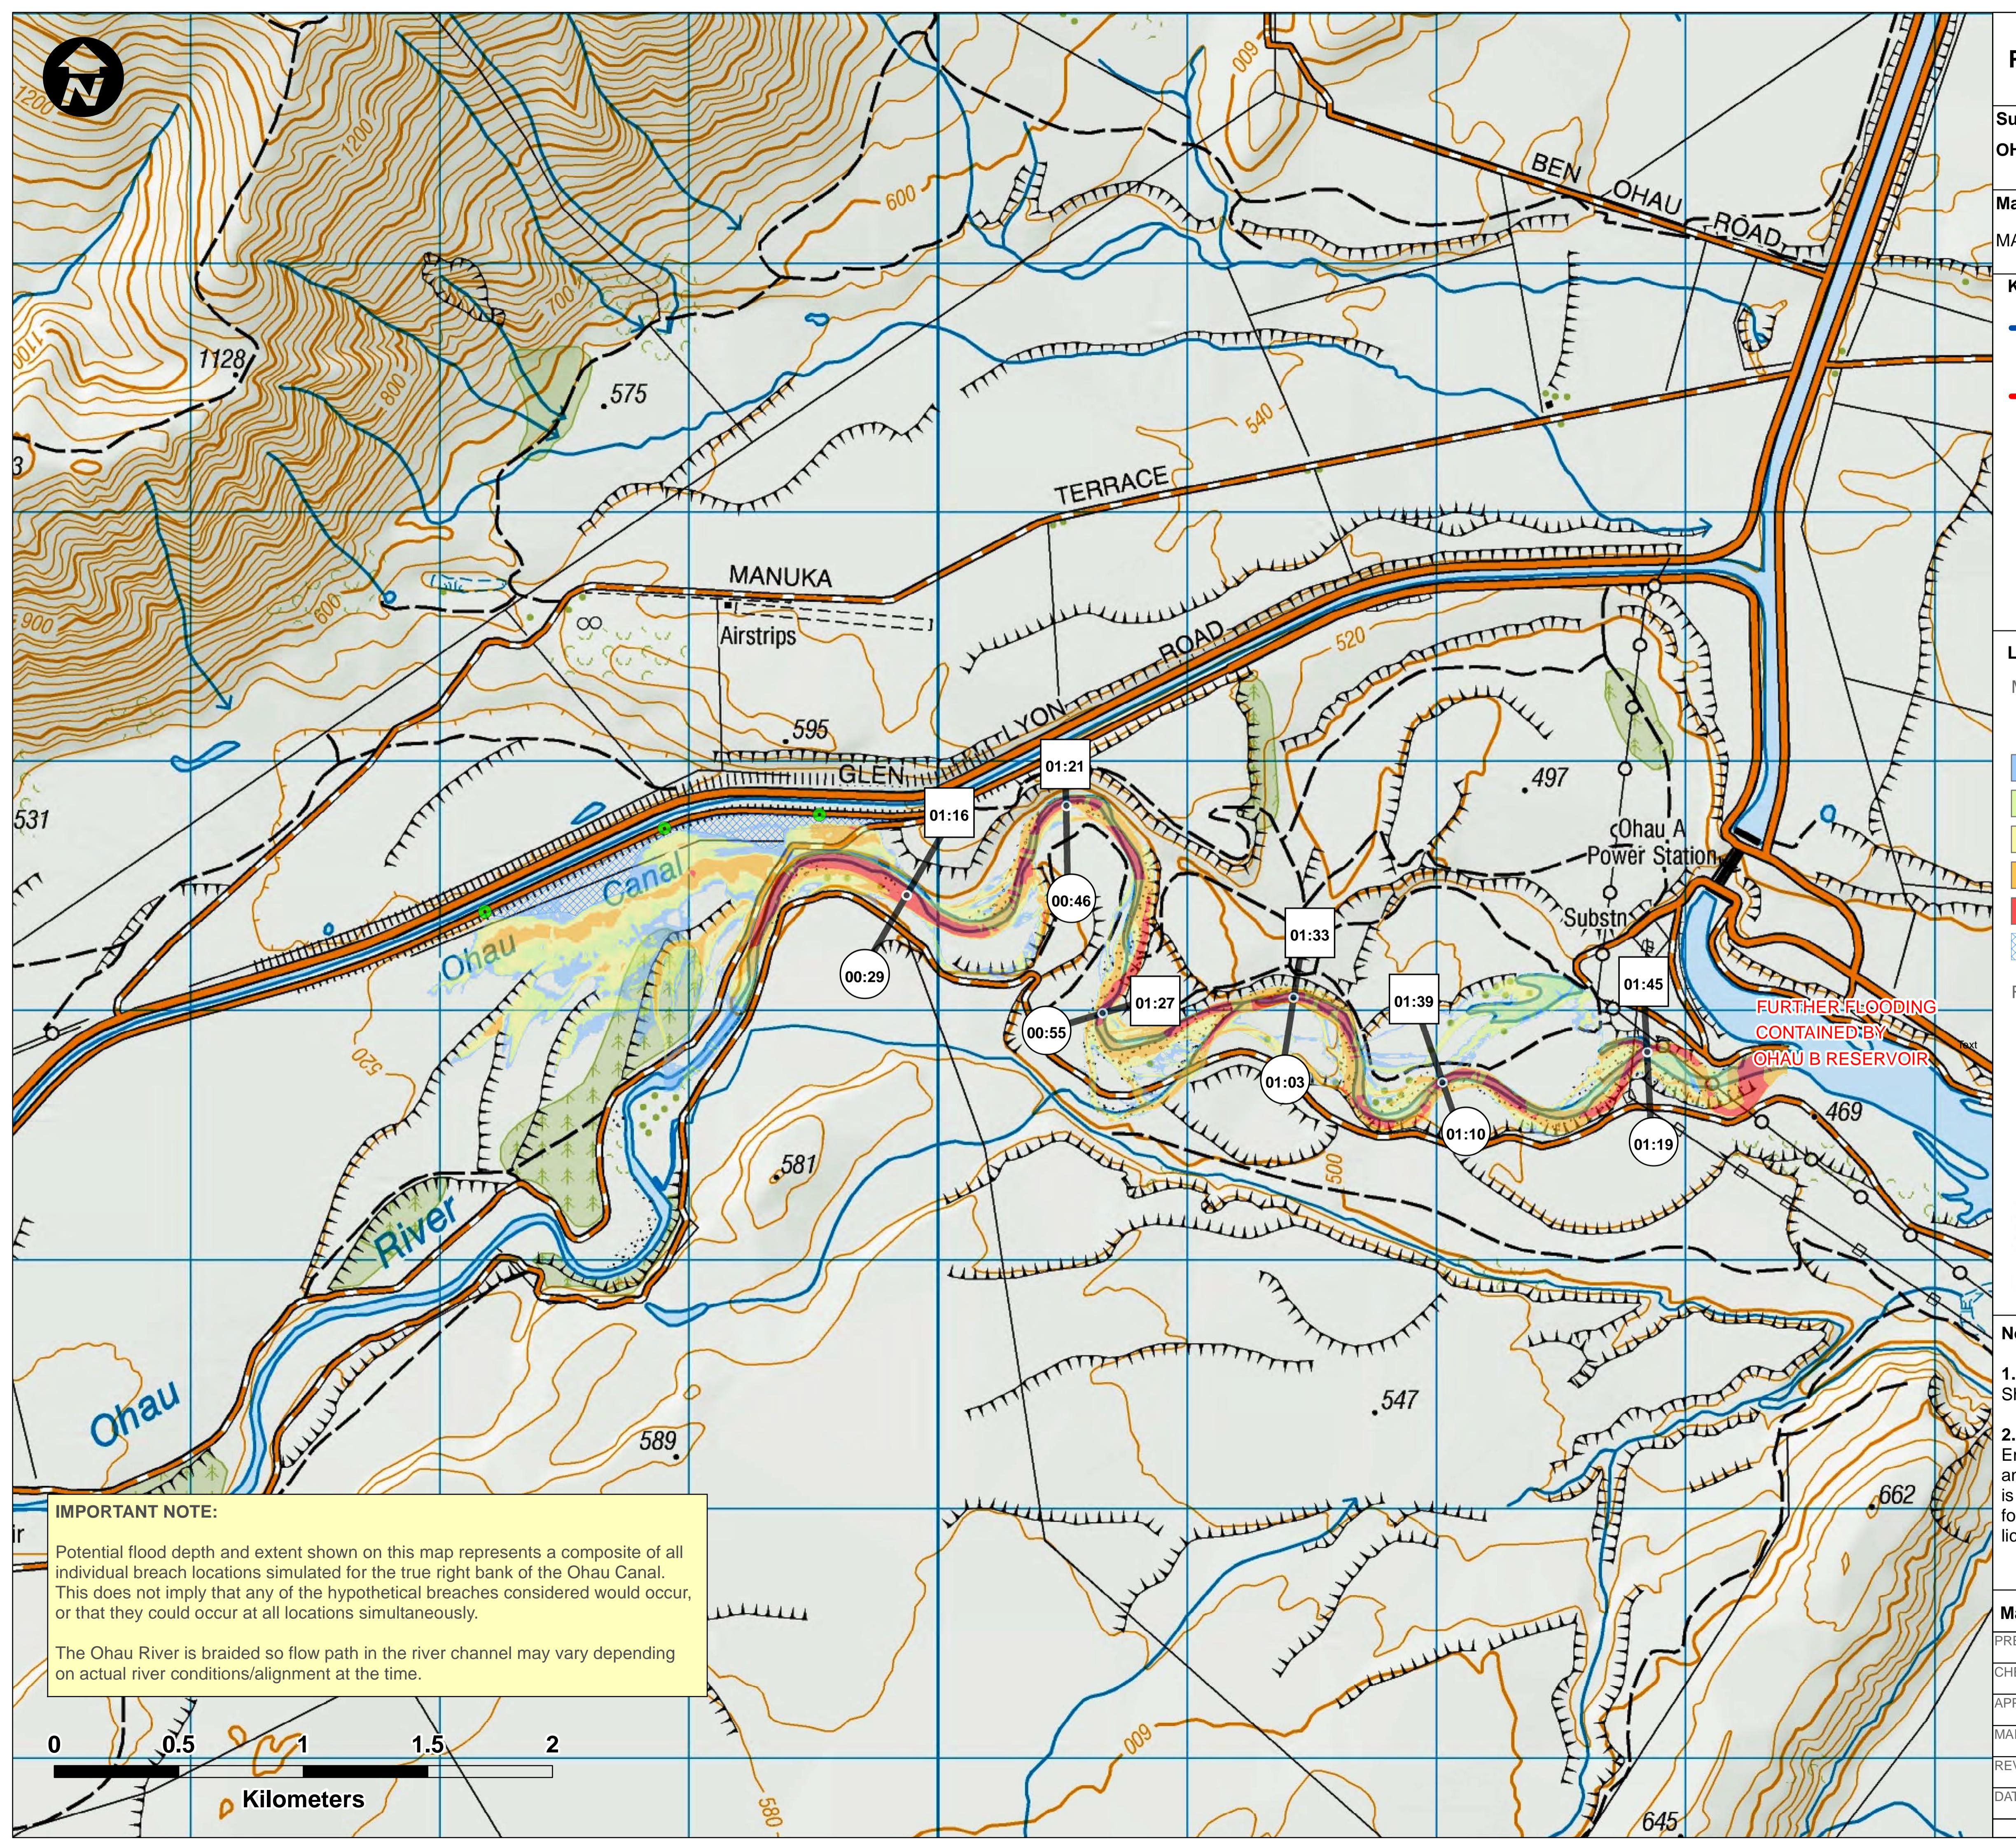
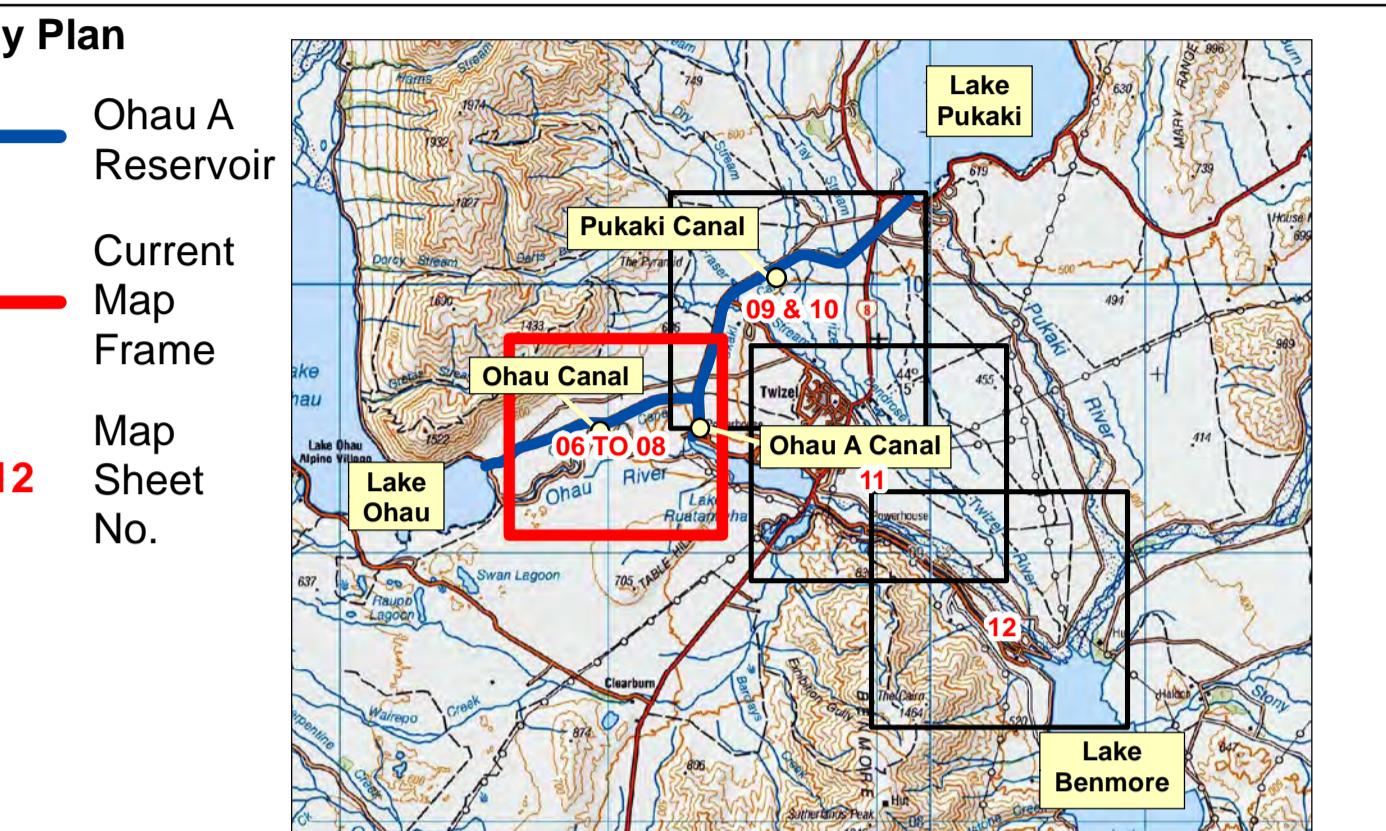
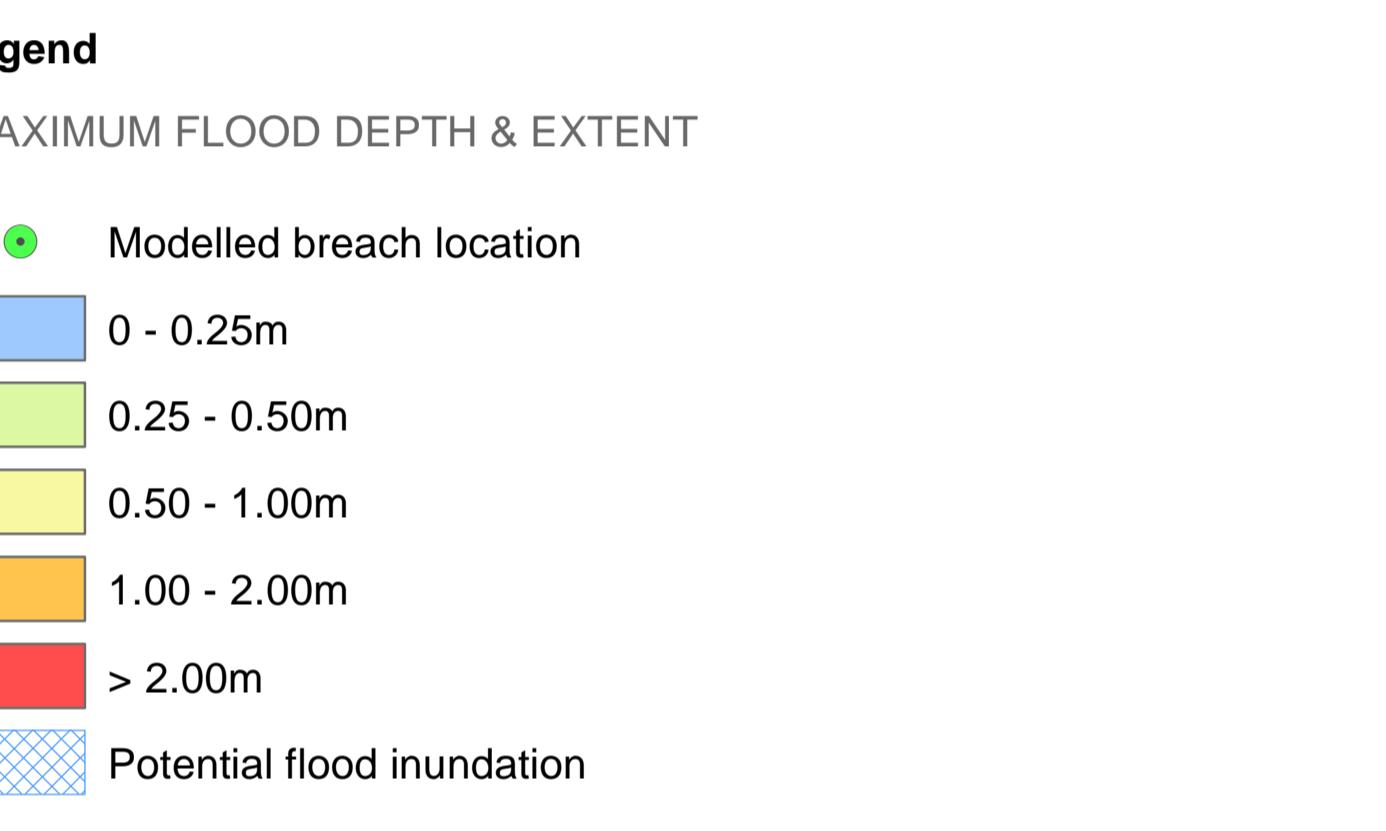
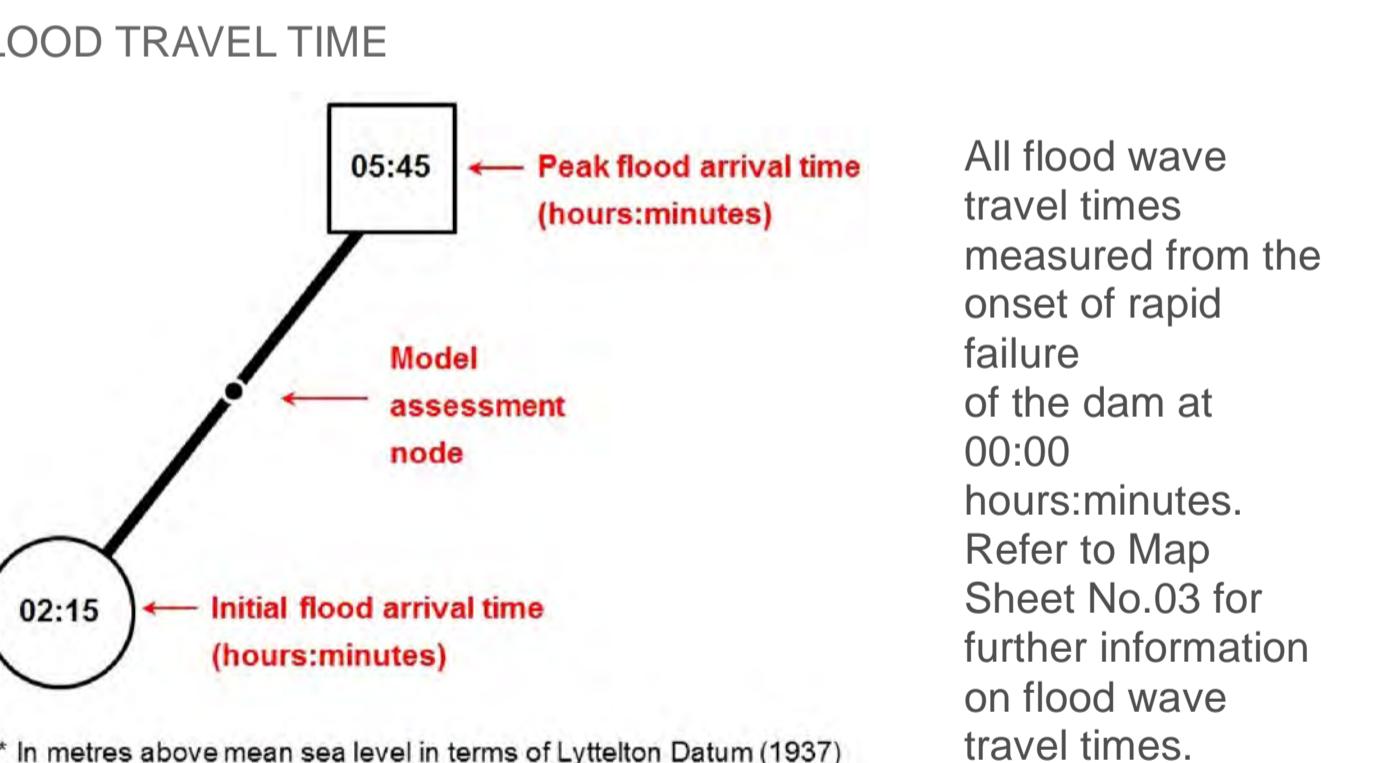
Subject Dam	Map Sheet No.
OHUA CANAL - TRUE RIGHT BANK	06

Map Information
MAXIMUM FLOOD DEPTH AND TRAVEL TIME

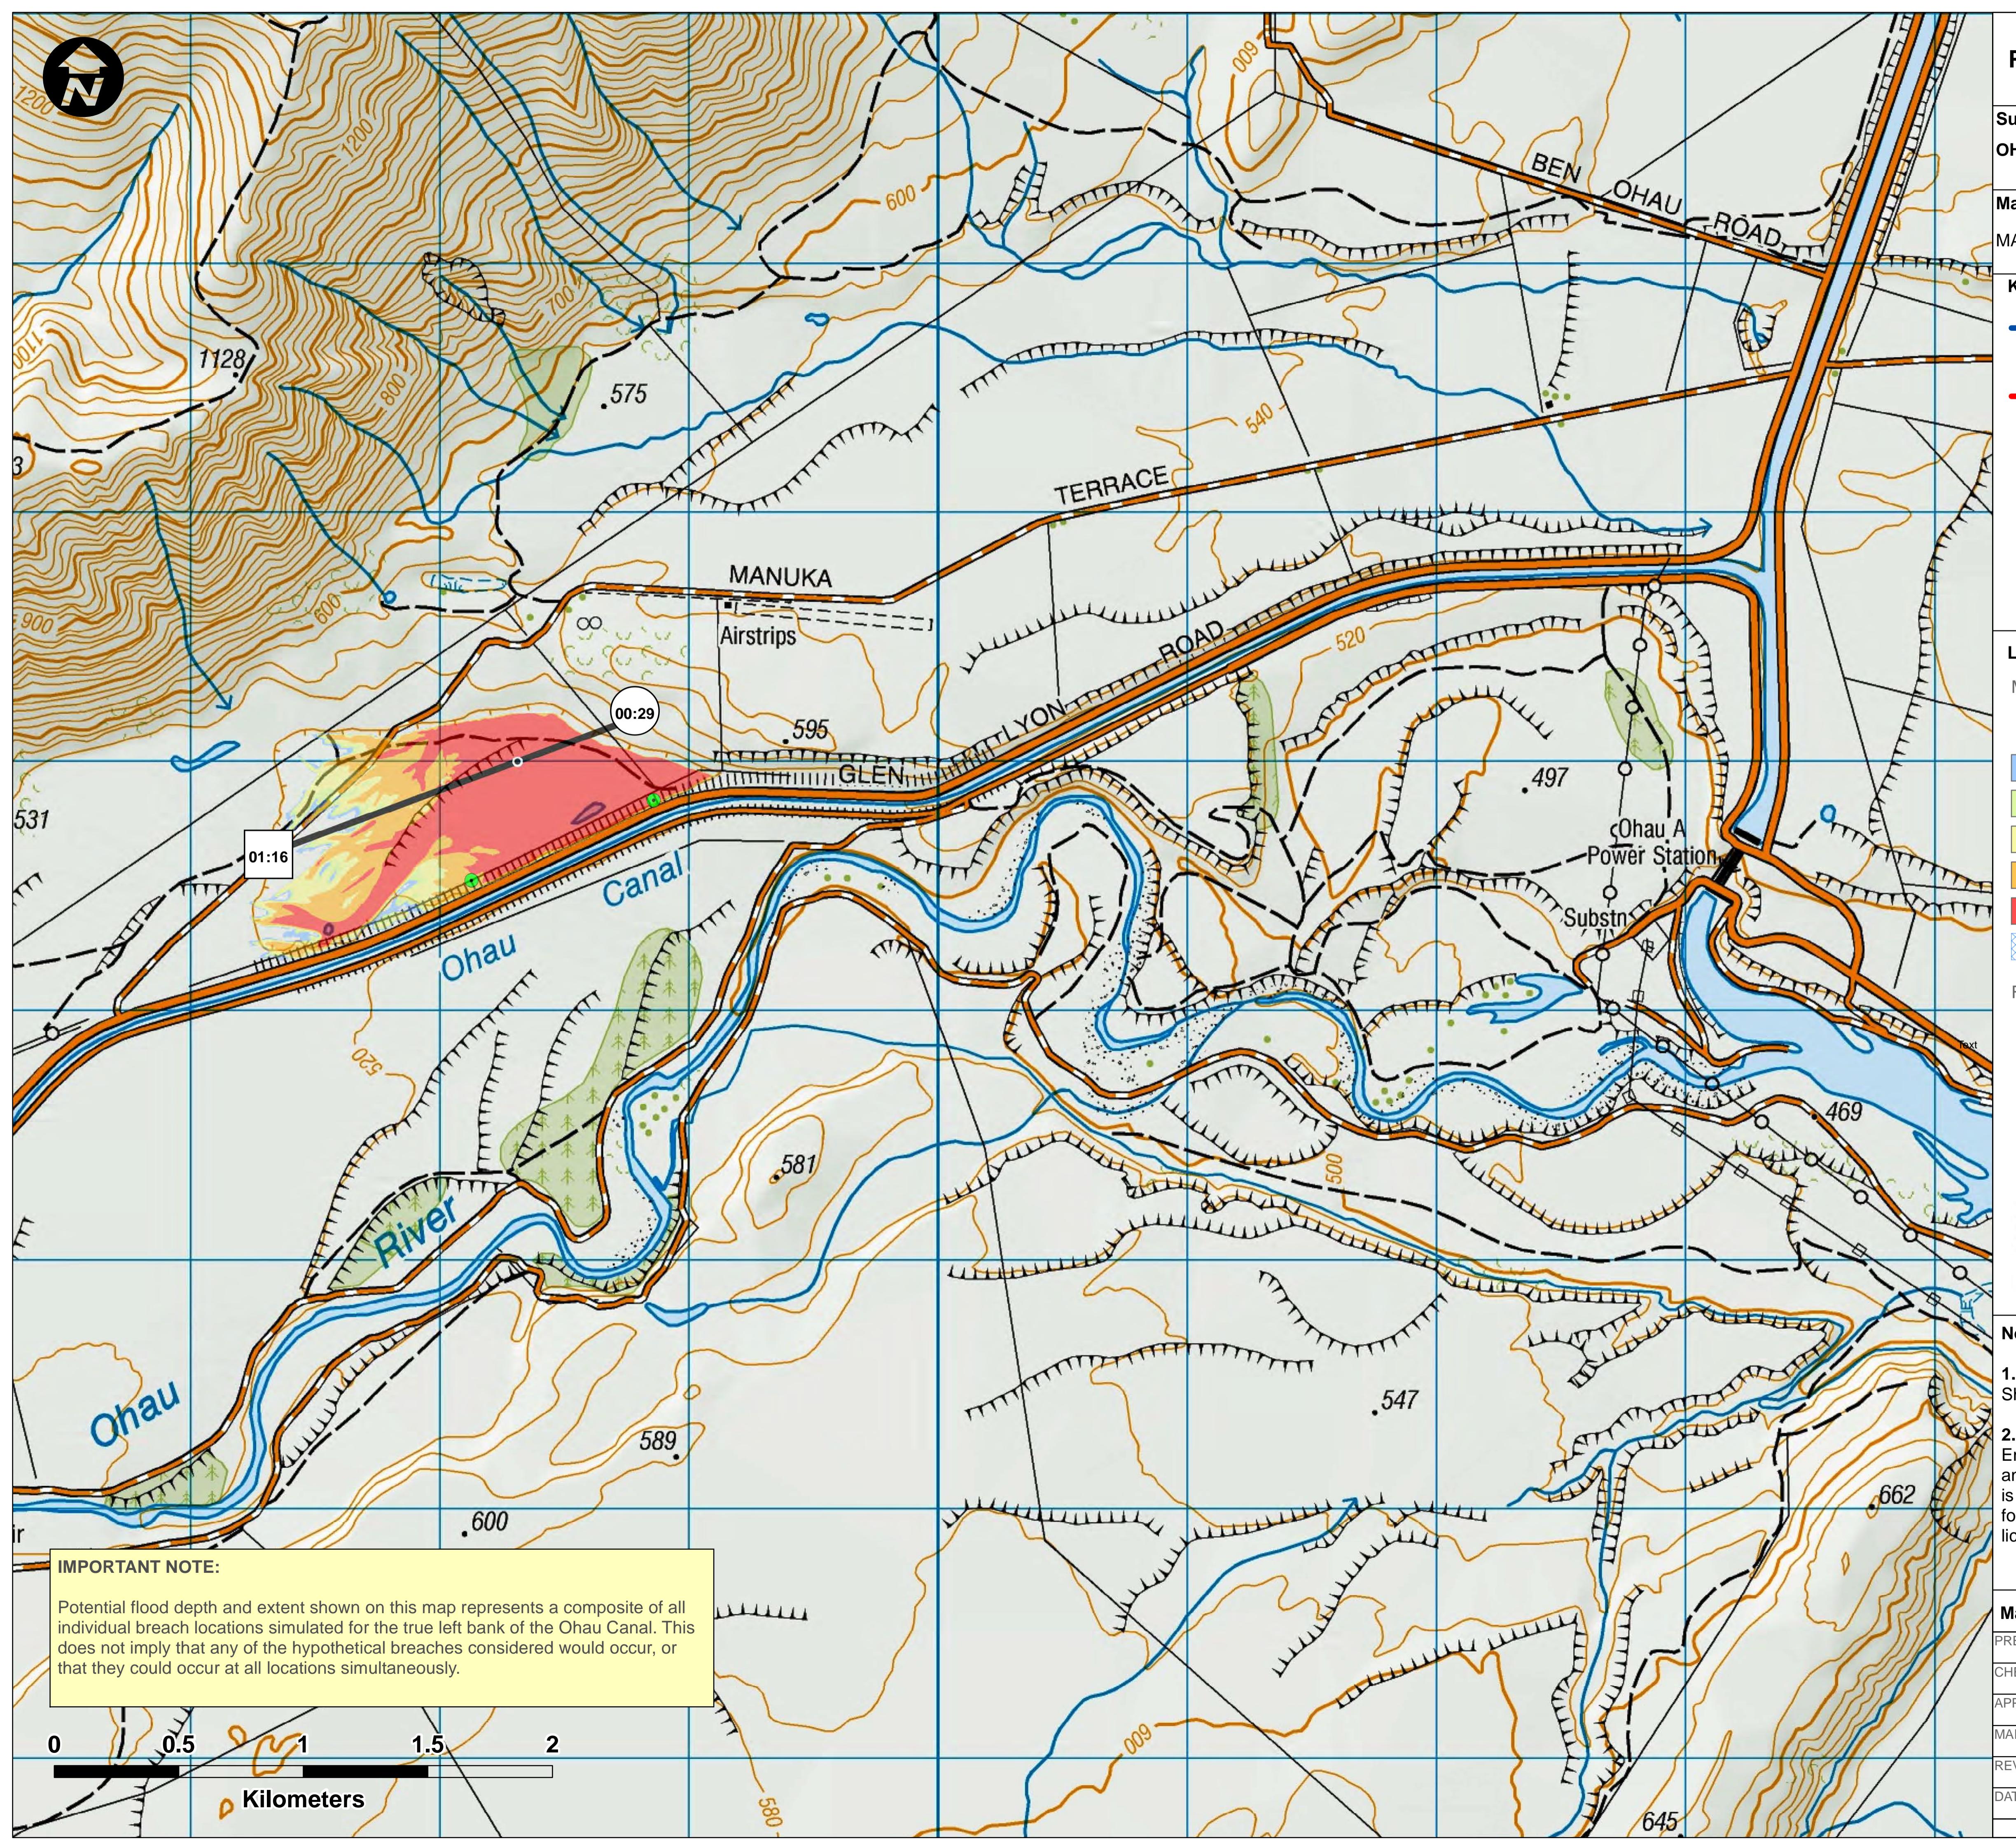
OHAU A RESERVOIR POTENTIAL FLOOD INUNDATION MAP BASED ON HYPOTHETICAL DAM-BREAK SCENARIOS			
Subject Dam OHAU CANAL - TRUE LEFT BANK	Map Sheet No. 07		
Map Information			
MAXIMUM FLOOD DEPTH AND TRAVEL TIME			
Key Plan			
Ohau A Reservoir			
Current Map Frame			
Map Sheet No. 12			
Legend			
MAXIMUM FLOOD DEPTH & EXTENT			
Modelled breach location			
0 - 0.25m

0.25 - 0.50m			
0.50 - 1.00m			
1.00 - 2.00m			
> 2.00m			
Potential flood inundation			
FLOOD TRAVEL TIME			
05:45	Peak flood arrival time (hours:minutes)
