Ohau A Reservoir – Dam-Break Inundation Maps for Emergency Management

Prepared for Meridian Energy Limited

Issue 2

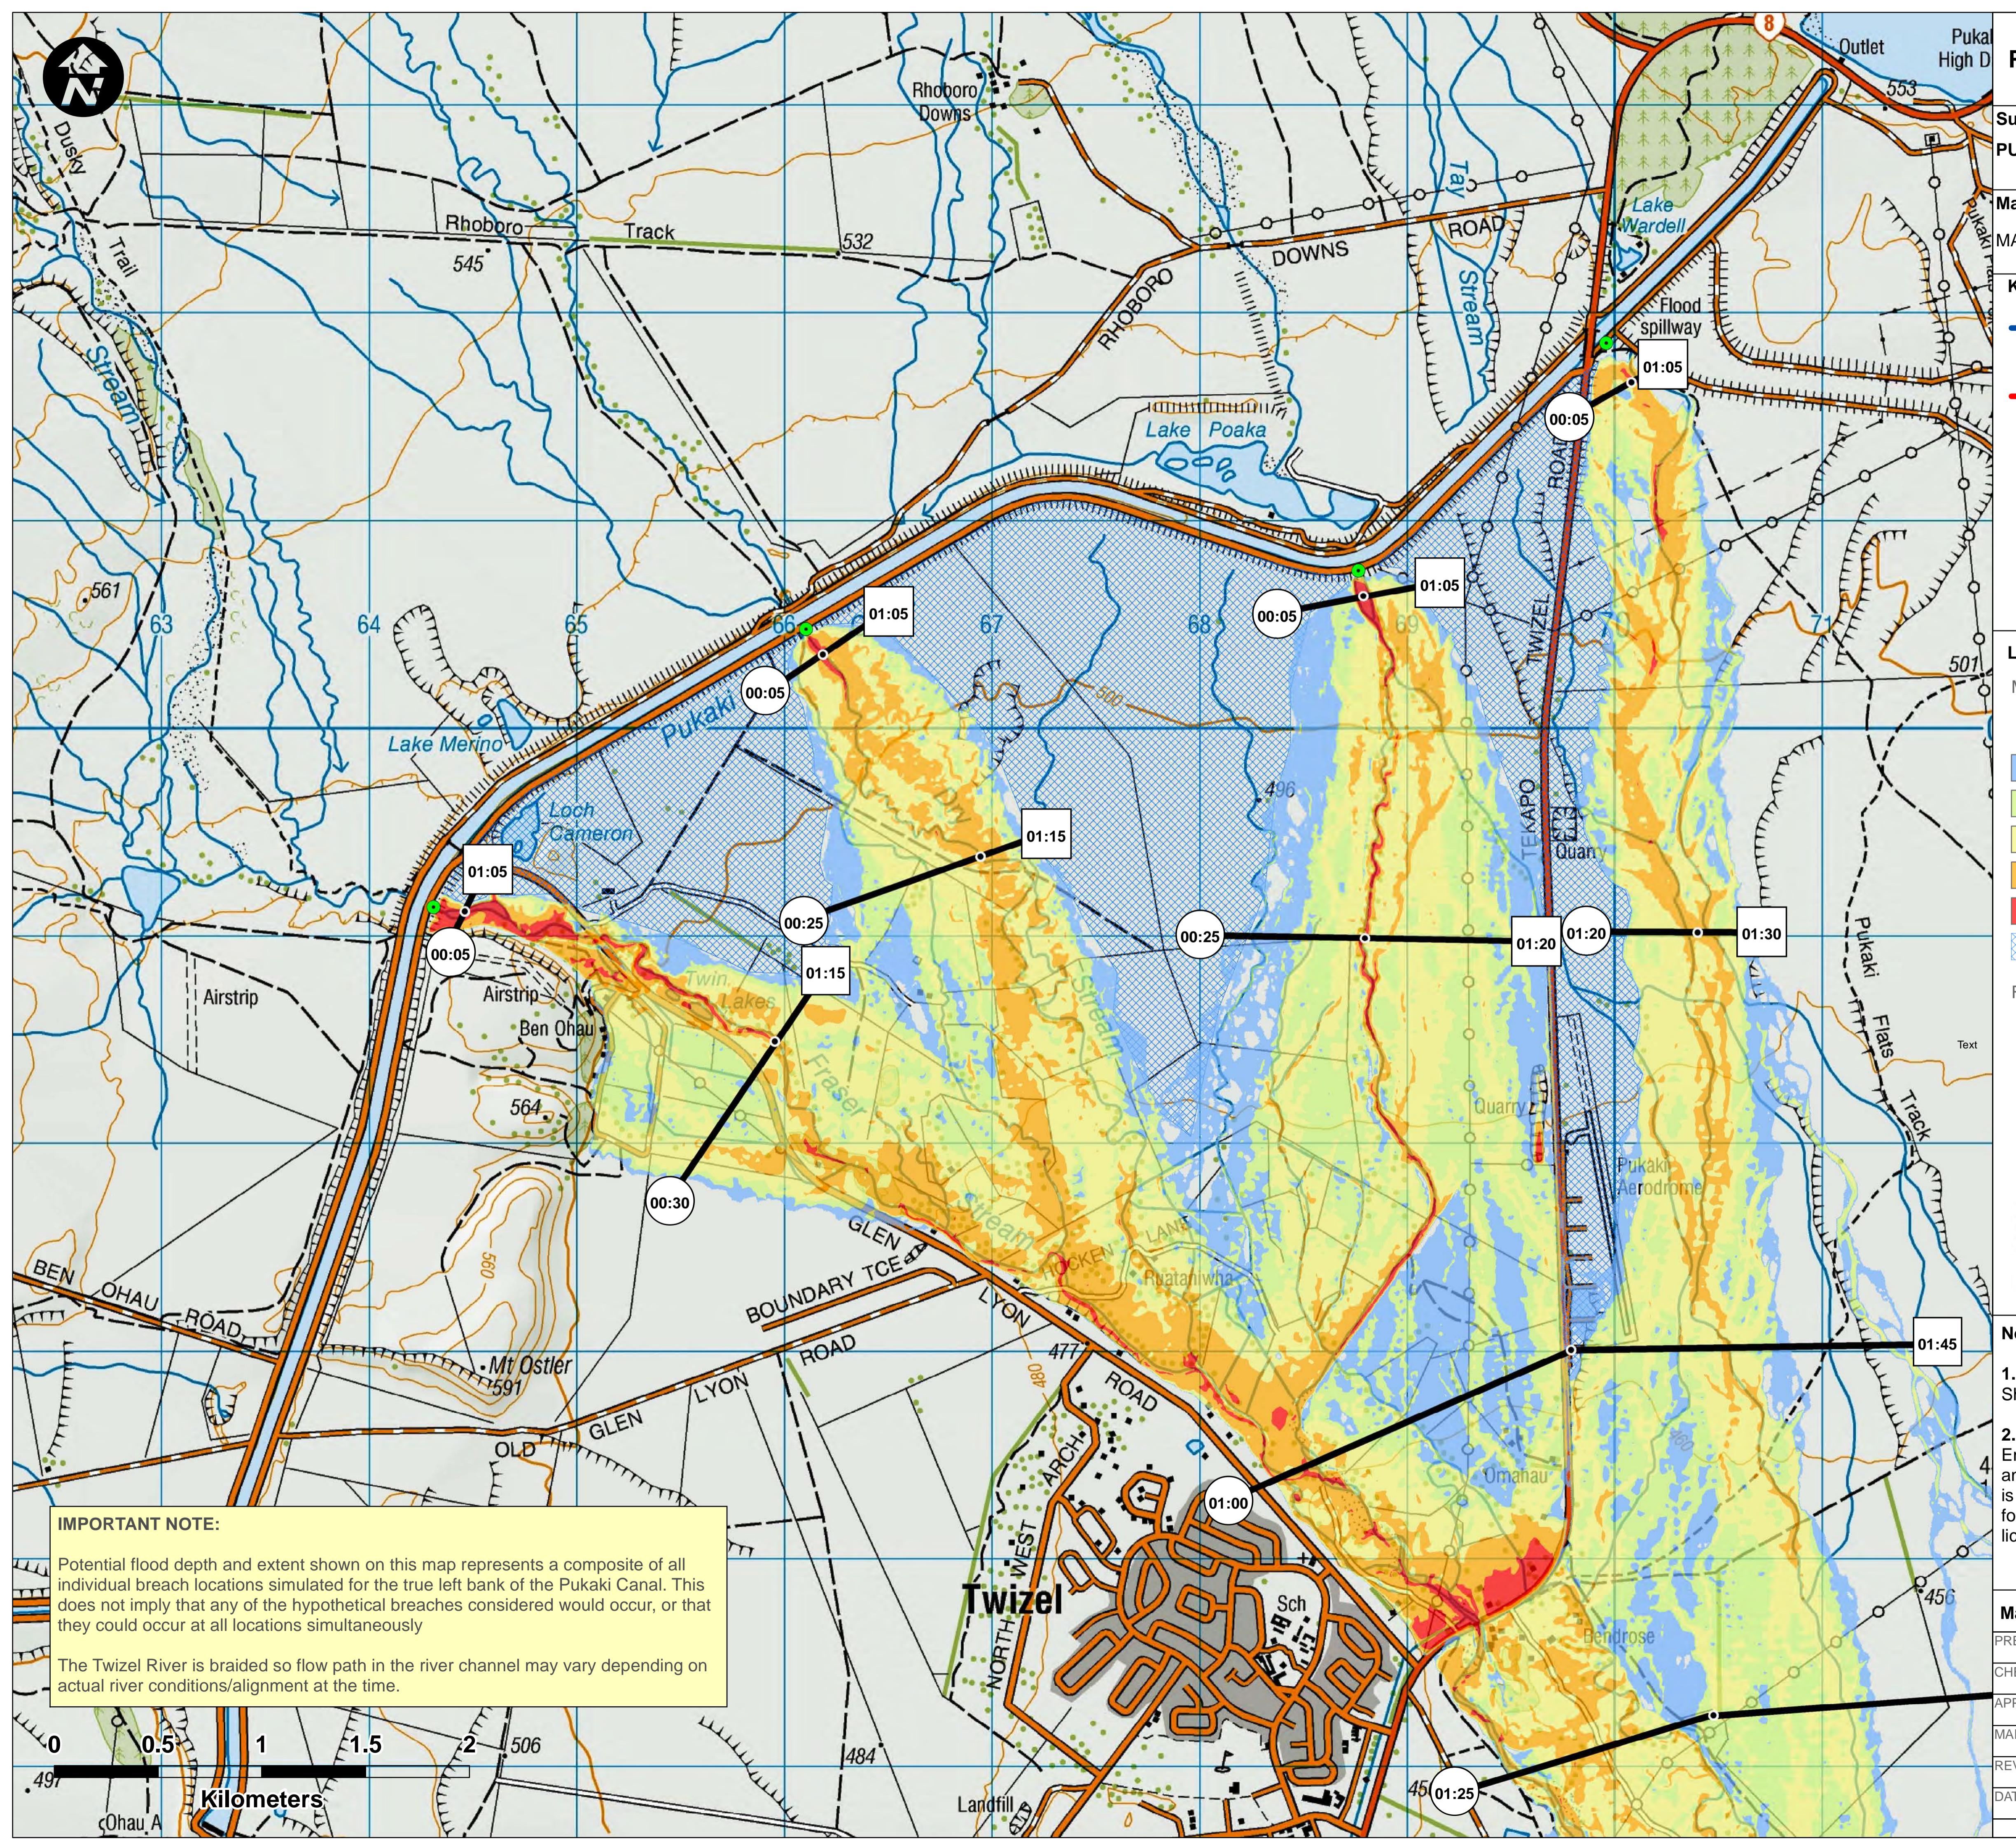
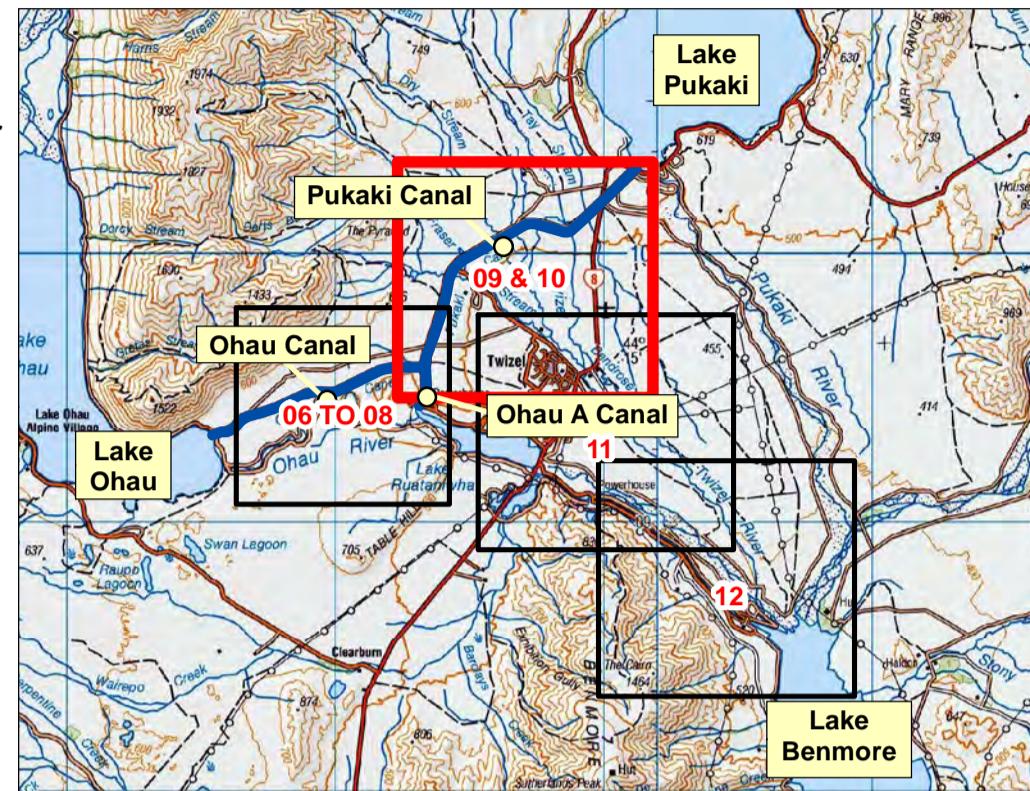
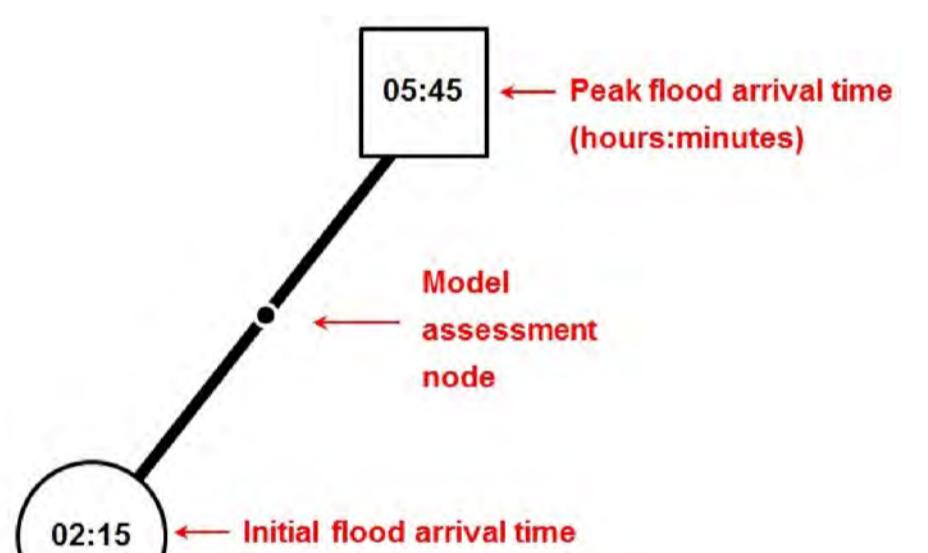
Subject Dam UKAKI CANAL - TRUE LEFT BANK	Map Sheet No. 10
---	-----------------------------------

All flood wave travel times measured from the onset of rapid failure of the dam at 00:00 hours:minutes. Refer to Map Sheet No.03 for further information on flood wave travel times.

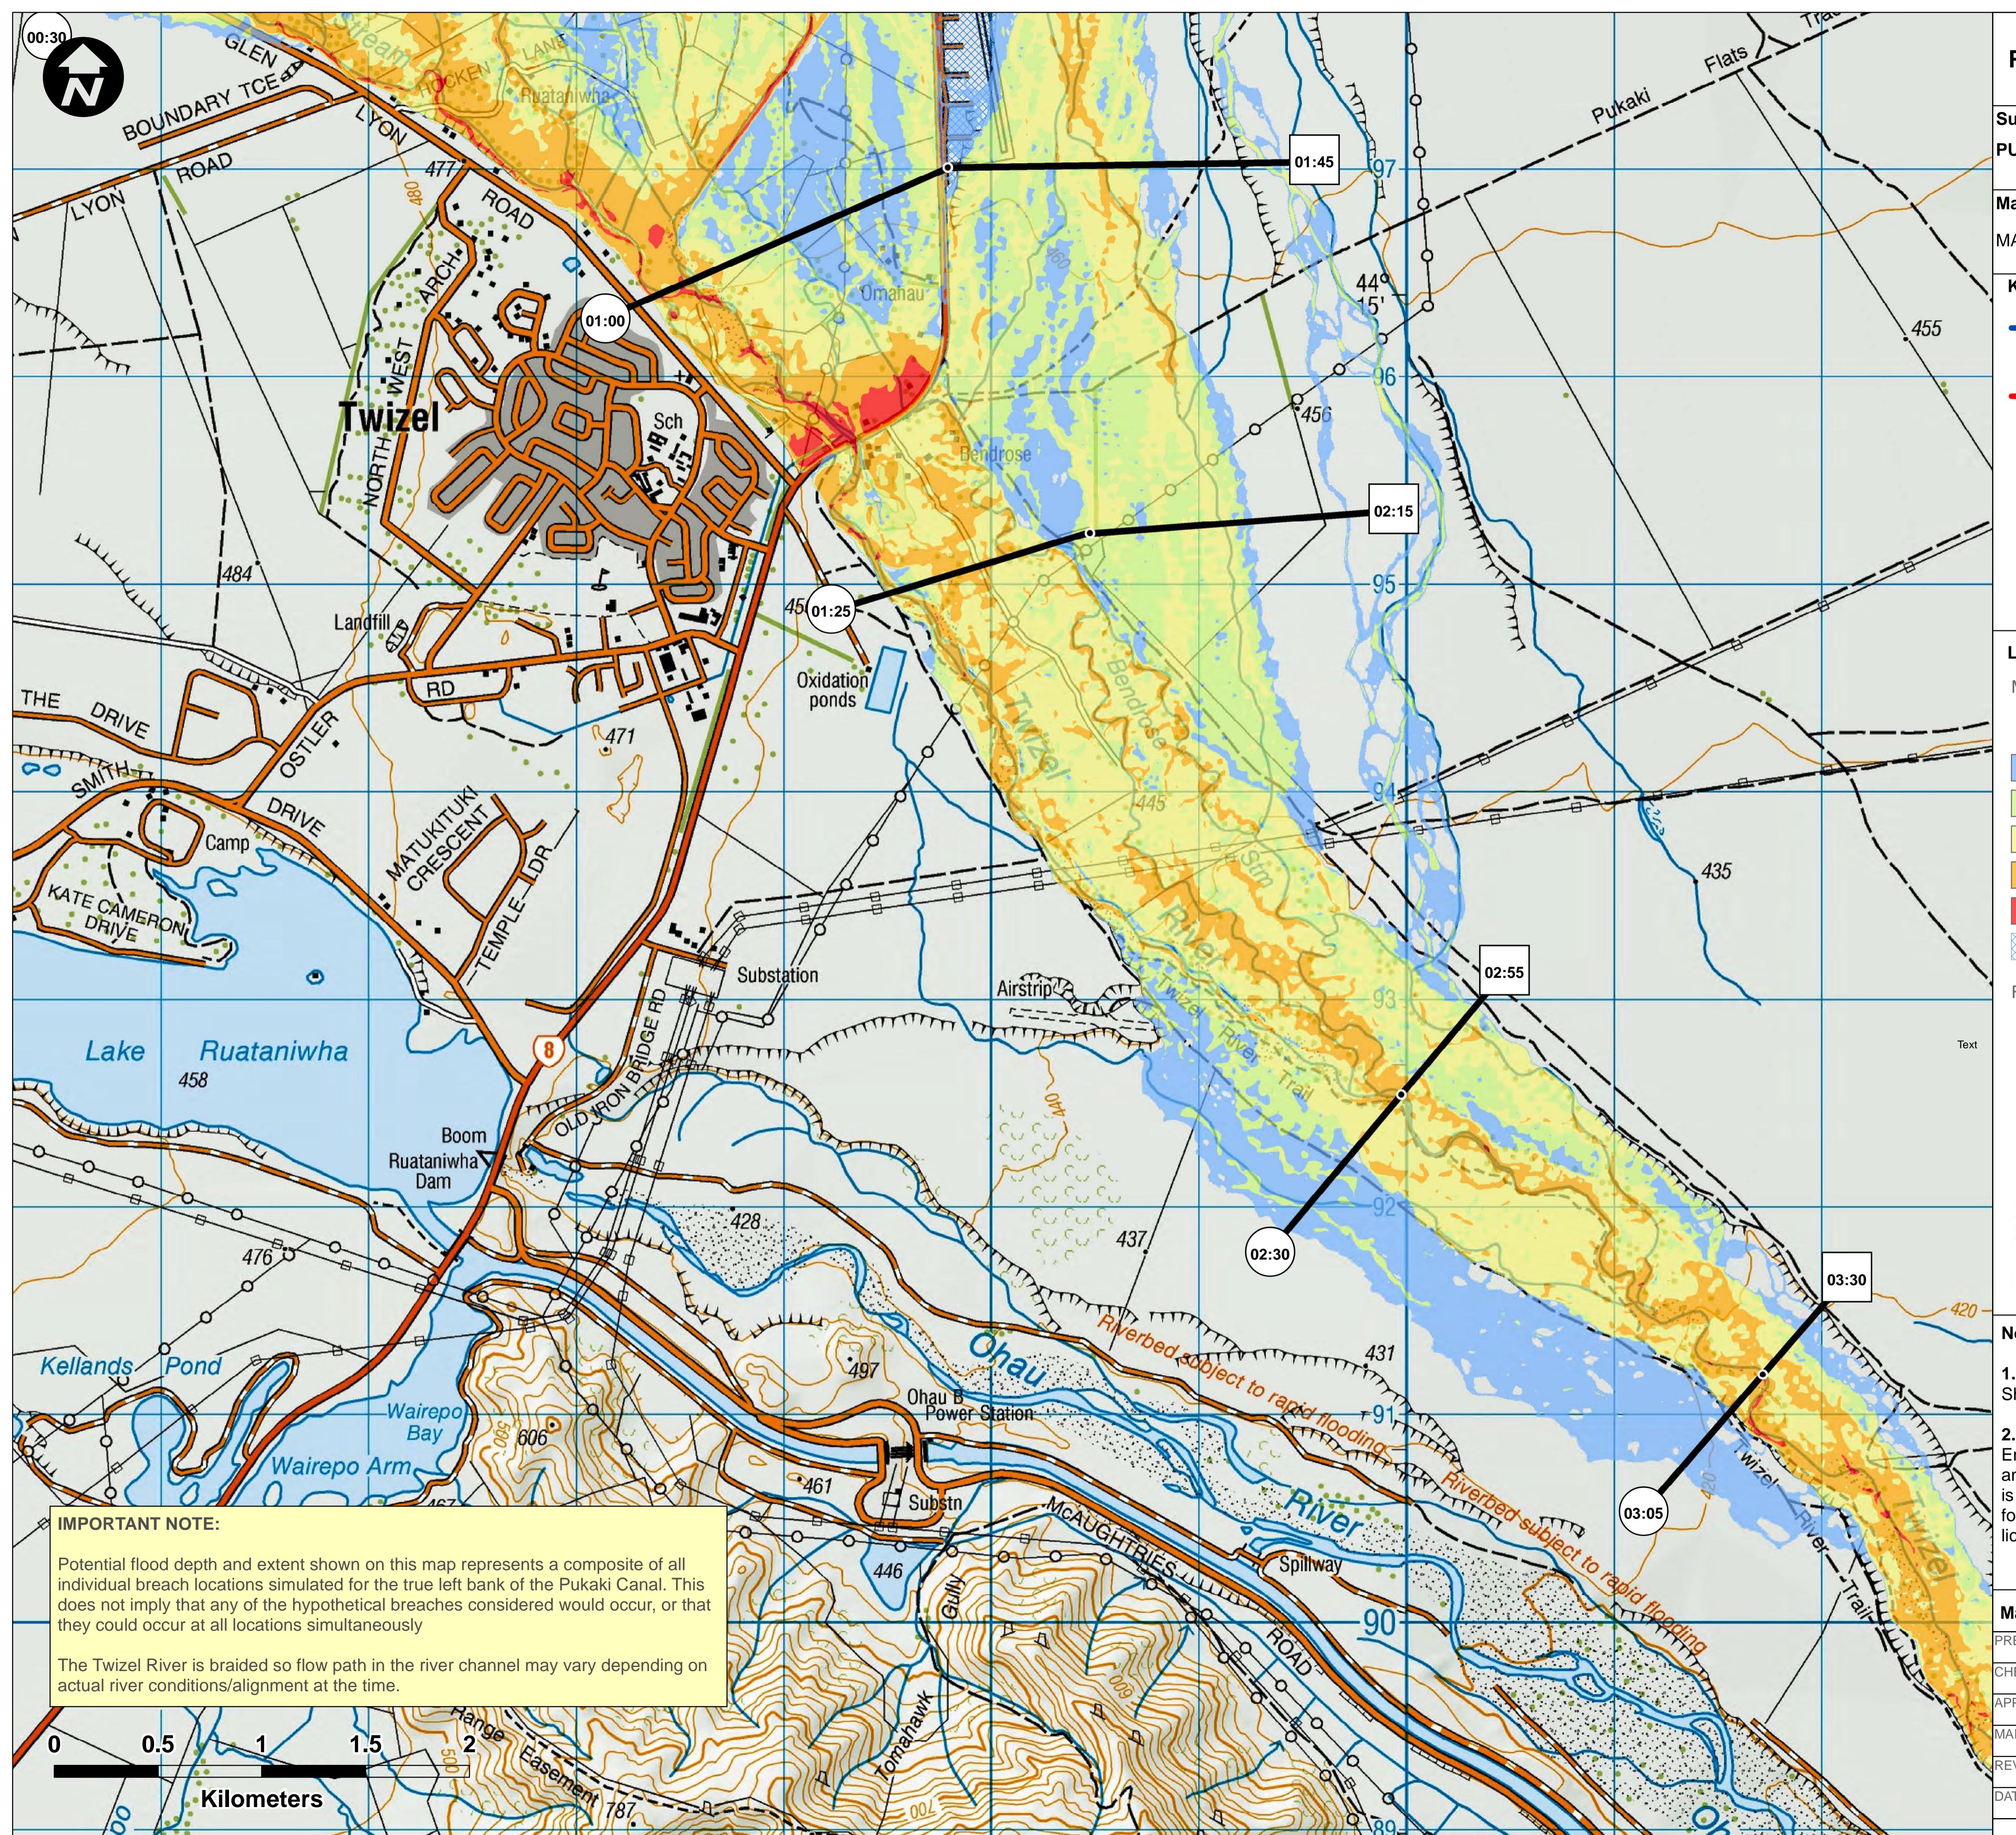
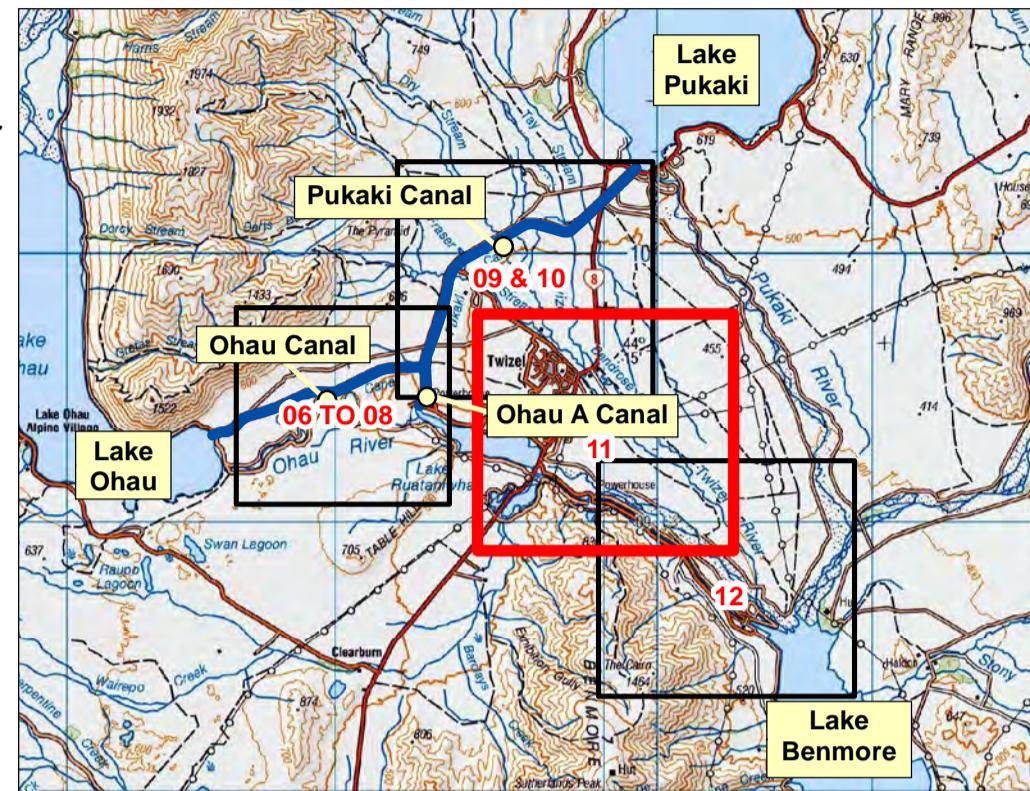
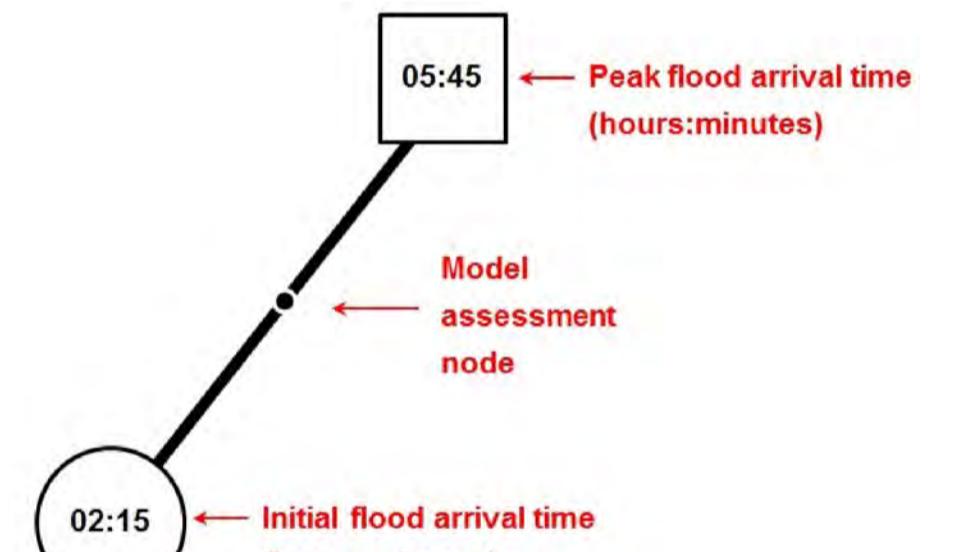
Subject Dam UKAKI CANAL - TRUE LEFT BANK	Map Sheet No. 11
--	----------------------------

All flood wave travel times measured from the onset of rapid failure of the dam at 00:00 hours:minutes. Refer to Map Sheet No.03 for further information on flood wave travel times

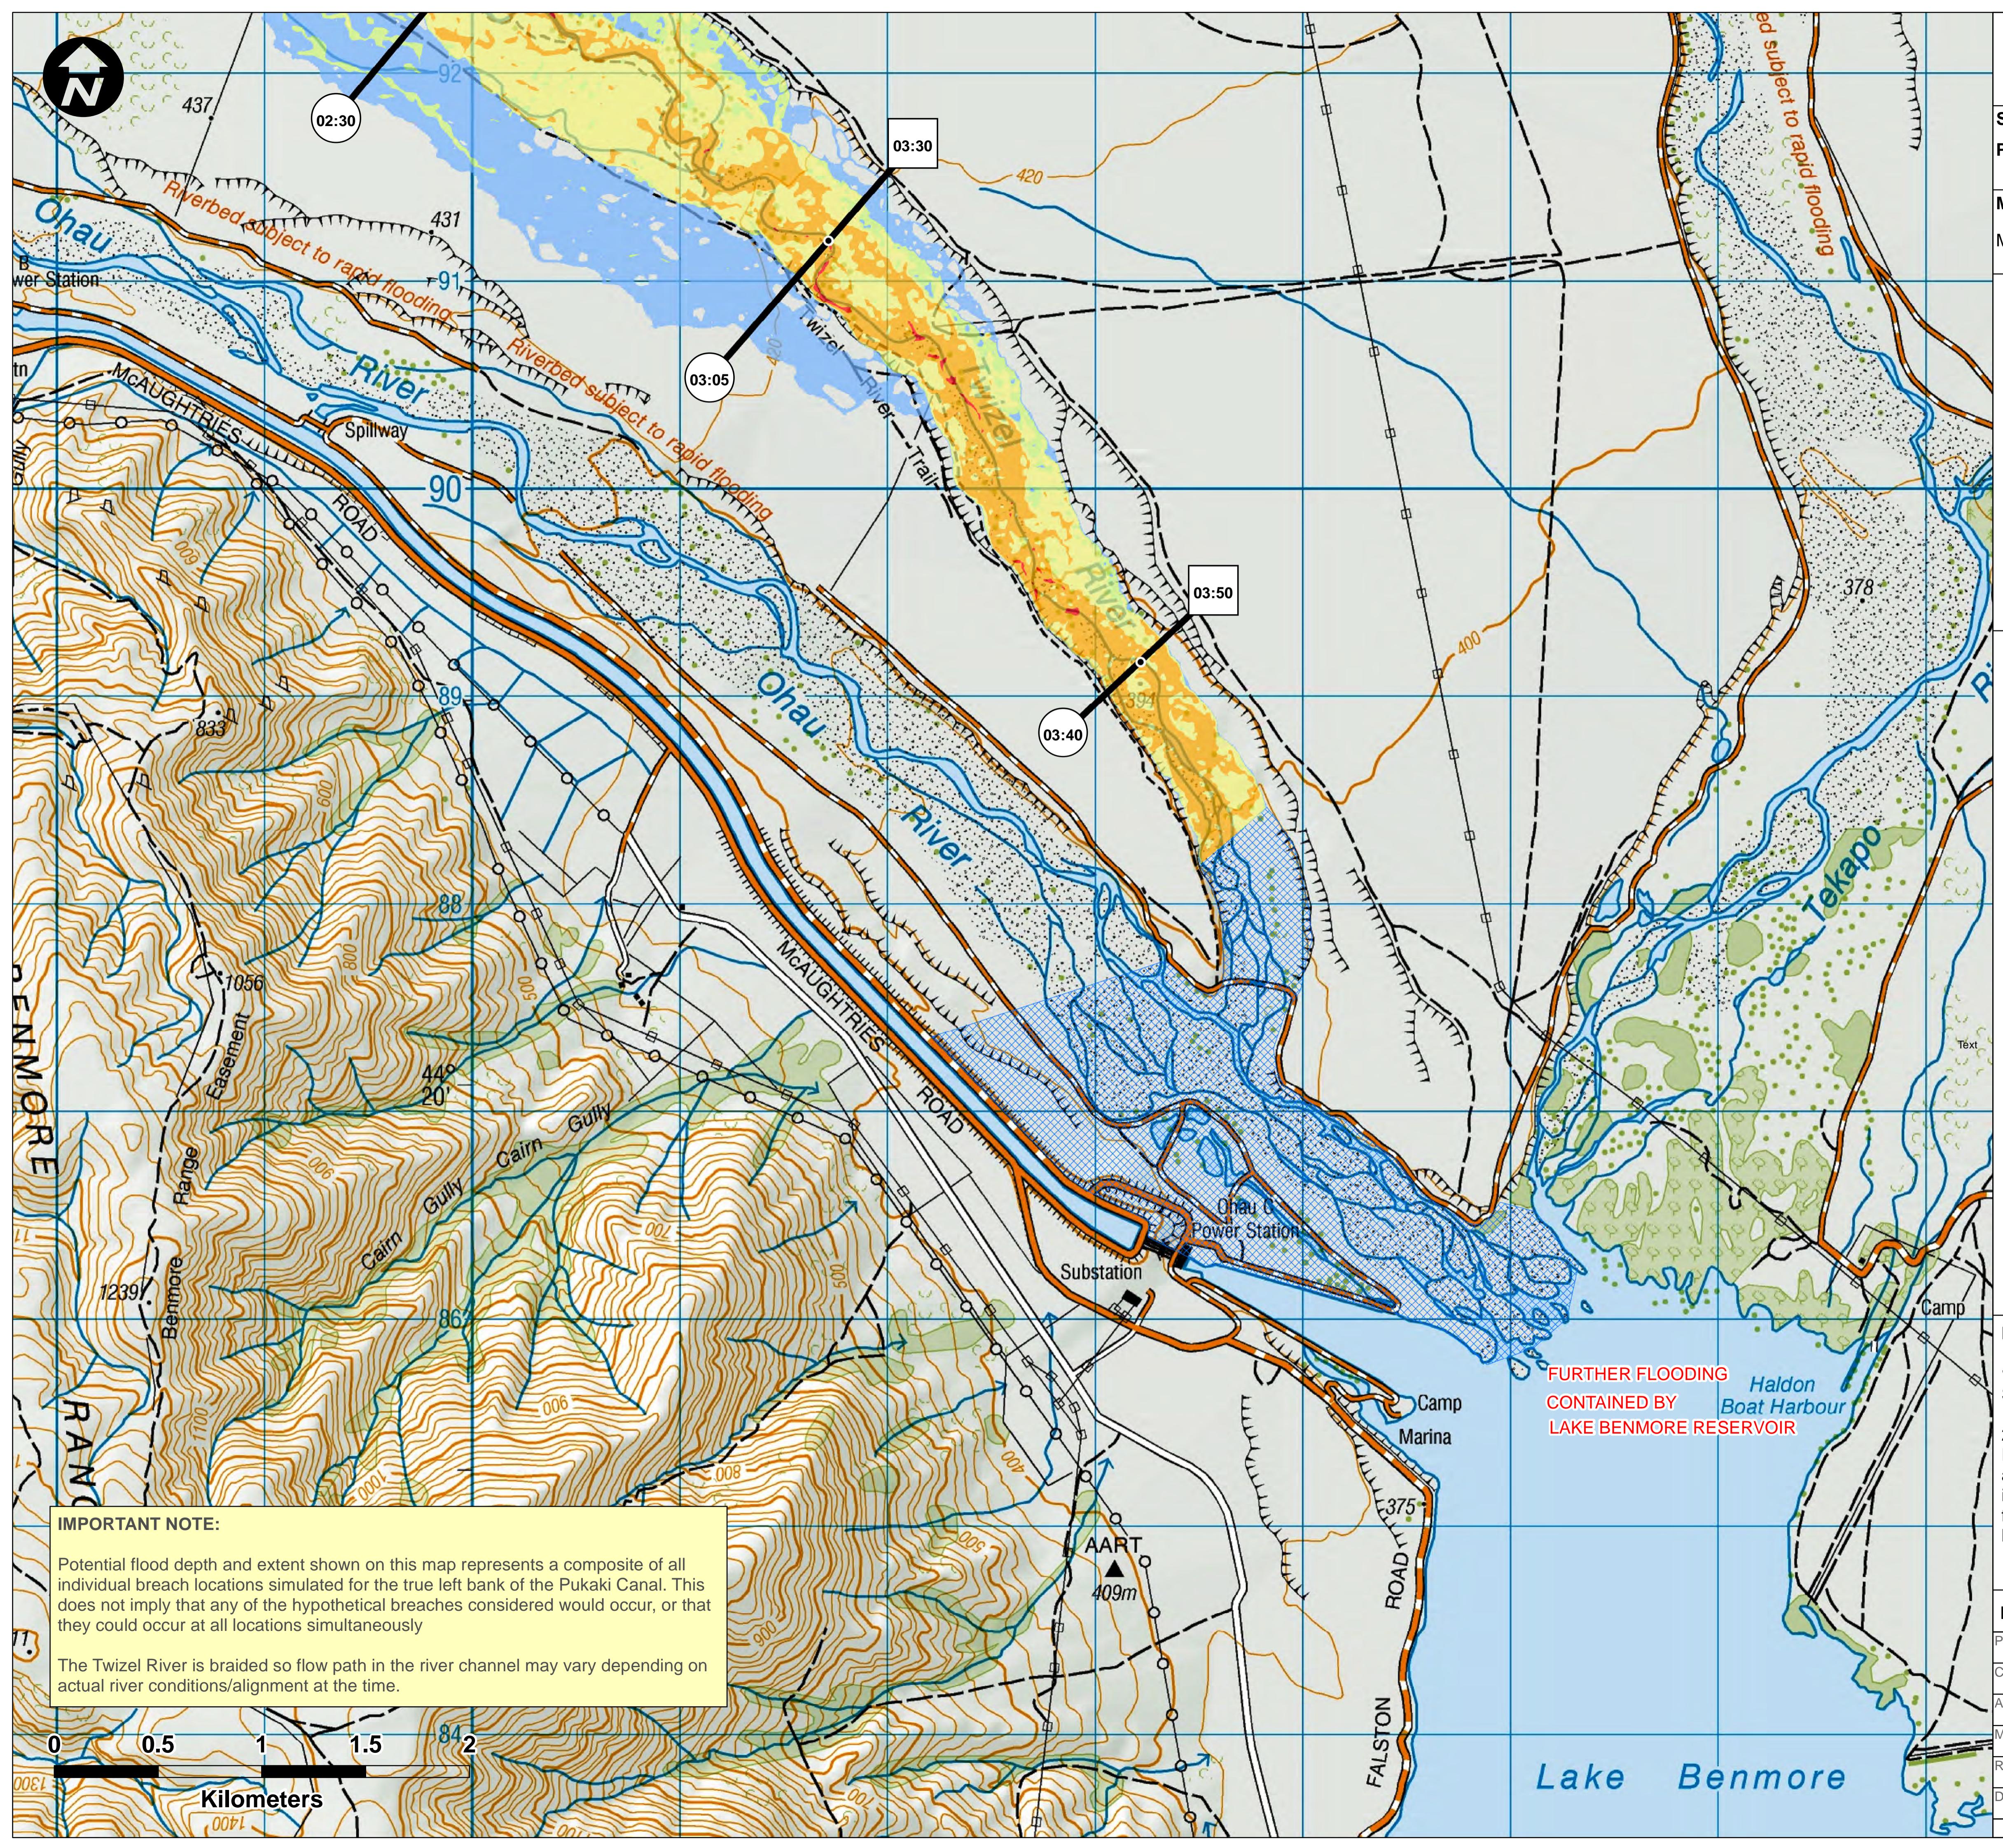
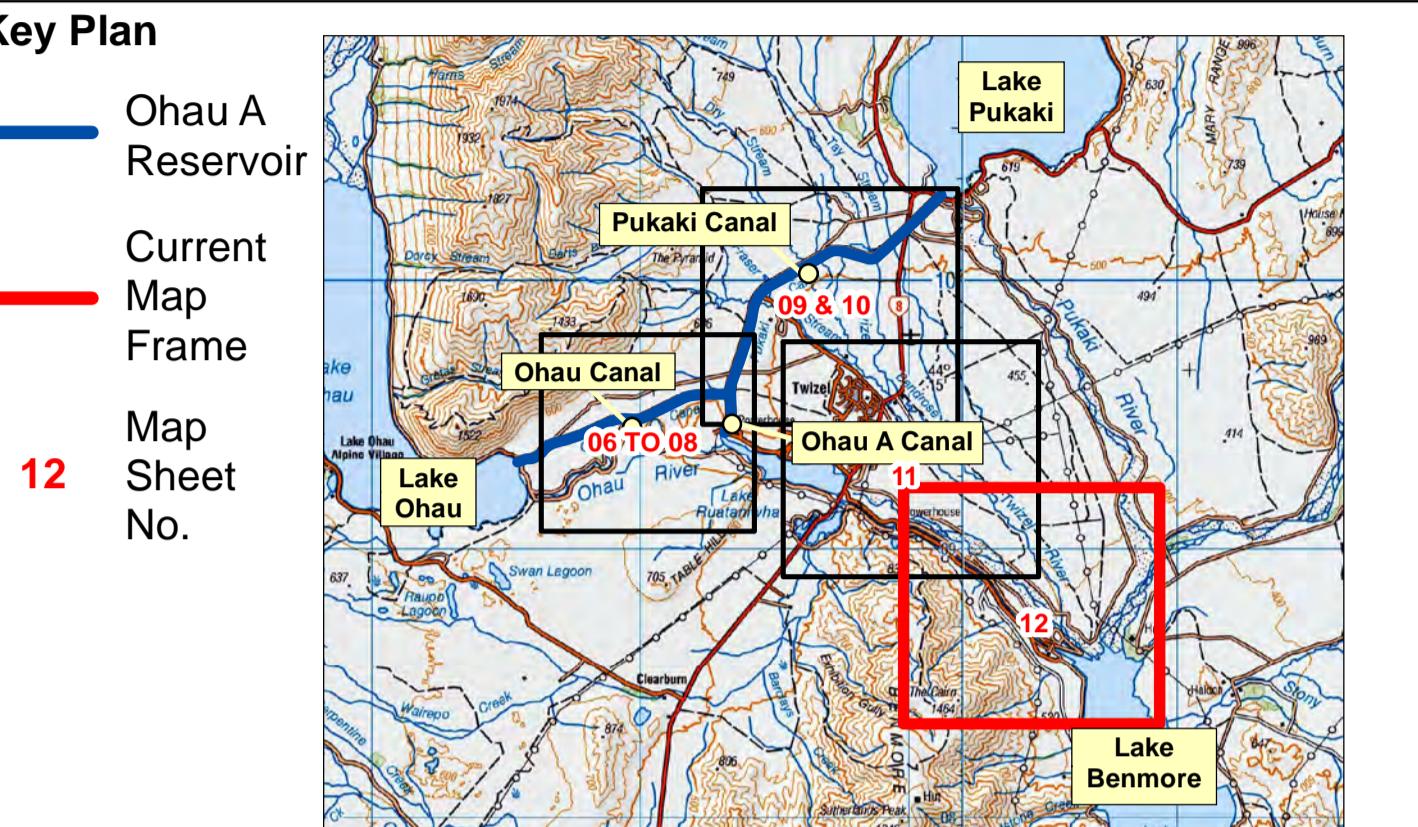
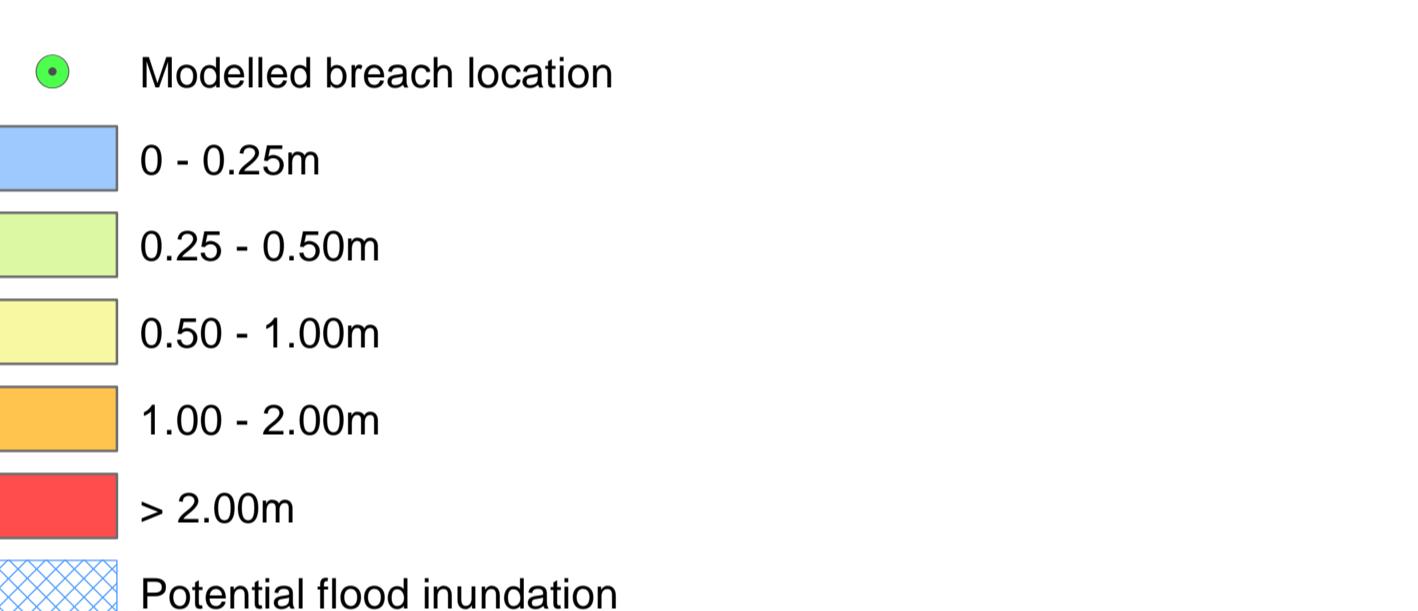
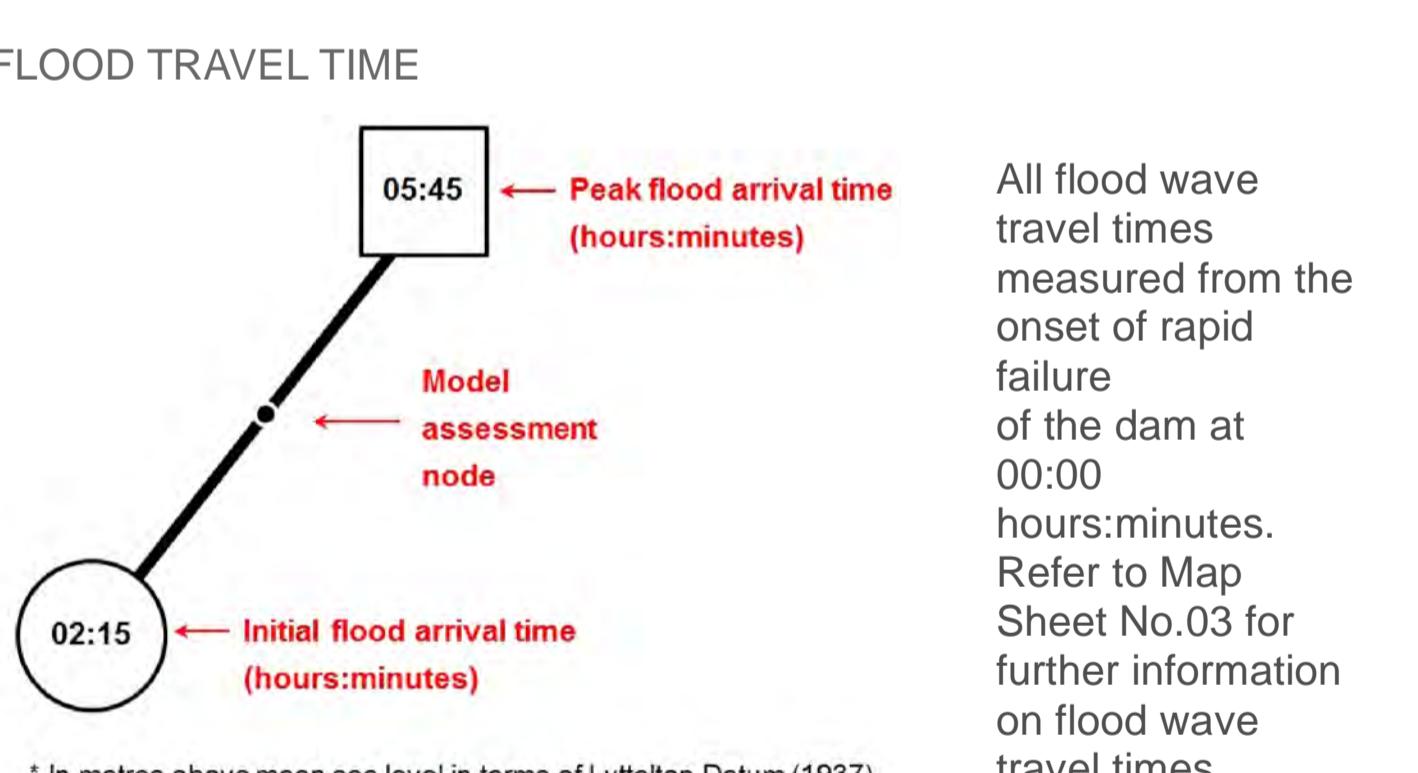
Subject Dam	Map Sheet No.
PUKAKI CANAL - TRUE LEFT BANK	12

Map Information
MAXIMUM FLOOD DEPTH AND TRAVEL TIME
