To: Independent Hearings Panel
From: David Pearson
Date: 18 June 2025
Re: Church of the Good Shepherd and Statue of Sheepdog – Proposed Heritage Overlay

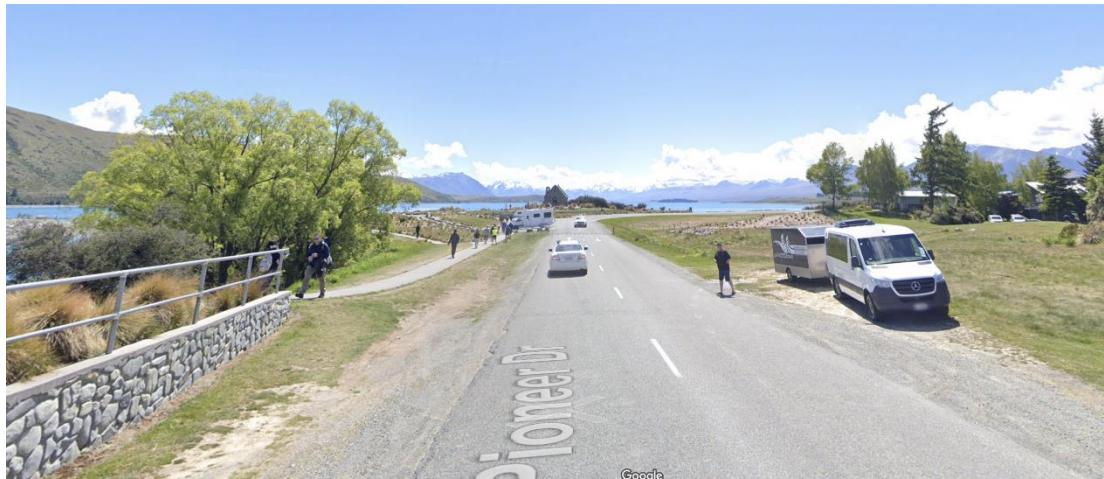
In reality, if one approaches the church by motor vehicle along Pioneer Drive, the road is more prominent and larger vehicles such as camper vans almost obscure the church as seen in the Google image on the following page.

The view of the church as seen from RK Viewpoint 1

Viewpoint 1 appears to be located on a slightly elevated position on a footpath near the end of the footbridge which spans across the Tekapo River. The image provided includes part of the road and a section of the footpath leading from the footbridge. Also seen from this viewpoint is a carpark along the side of the road which appears to contain an array of vehicles including SUVs. Across the road is the area of land in question, known as Area 'A'. In the far distance the church can just be seen.

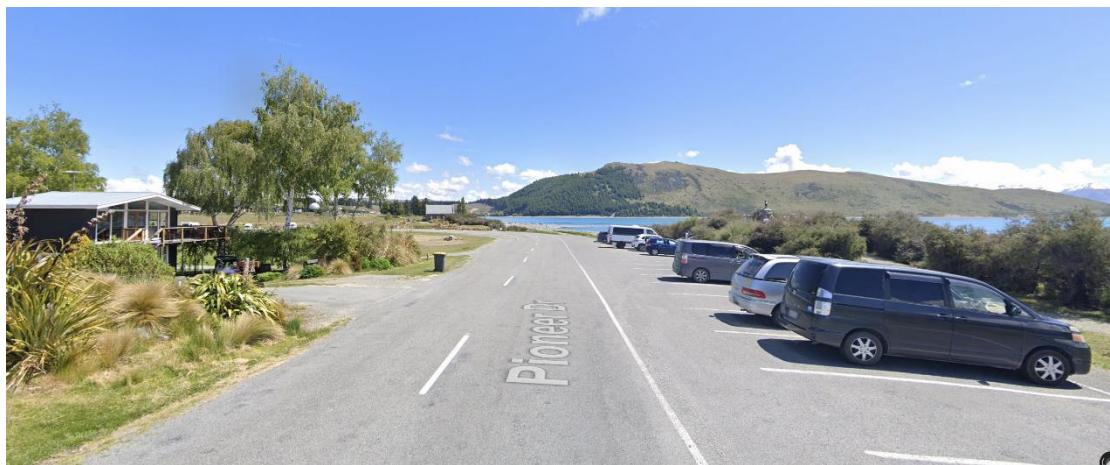
Looking at the aerial photograph in his statement, Viewpoint 2 appears to be located further back along Pioneer Drive than the image would suggest. In reality, the view from that location is likely to include cars parked in a parking area adjacent to the statue of the Sheep Dog. It would also include a larger expanse of roadway, a private dwelling at no 24 Pioneer Drive and part of Area 'A'. In the distance, the roof of the church can be just made out.

The view of the church as seen from RK Viewpoint 2

The image that Mr Knott includes as that taken from Viewpoint 2 includes a section of Pioneer Driven, part of Area 'A' and a view of buildings in Tekapo township on the other side of Tekapo River, including the dome of the Dark Sky project.

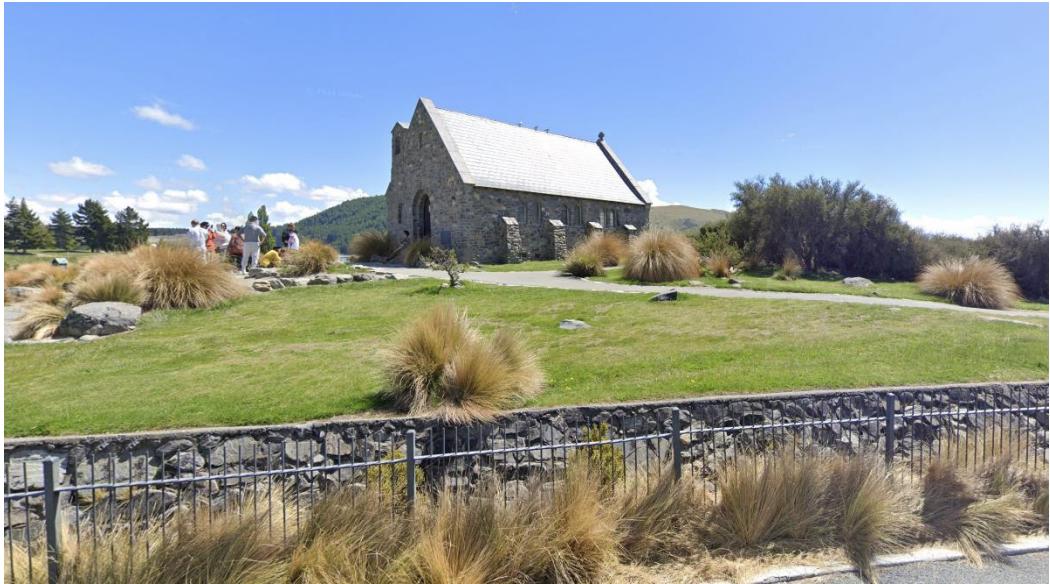
road. The church is then seen as it was originally conceived in isolation on its elevated mound against a background of the sky, the lake and the mountains.

View of the Church of the Good Shepherd as viewed from the bend in Pioneer Drive

At this point, the area of land known as Area 'A' is behind the viewer and does not contribute significantly to the visitor experience and in fact is unlikely to even feature in the viewers' consciousness. I believe this would still be the case if Area 'A' was developed in accordance with the development controls contained within the 'low density' zoning.
